NATIONAL
TRANSPORTATION
SAFETY
COMMITTEE

AIRCRAFT ACCIDENT REPORT

PT. Dirgantara Air Service Flight AW 3130

BN-2B PK-VIY

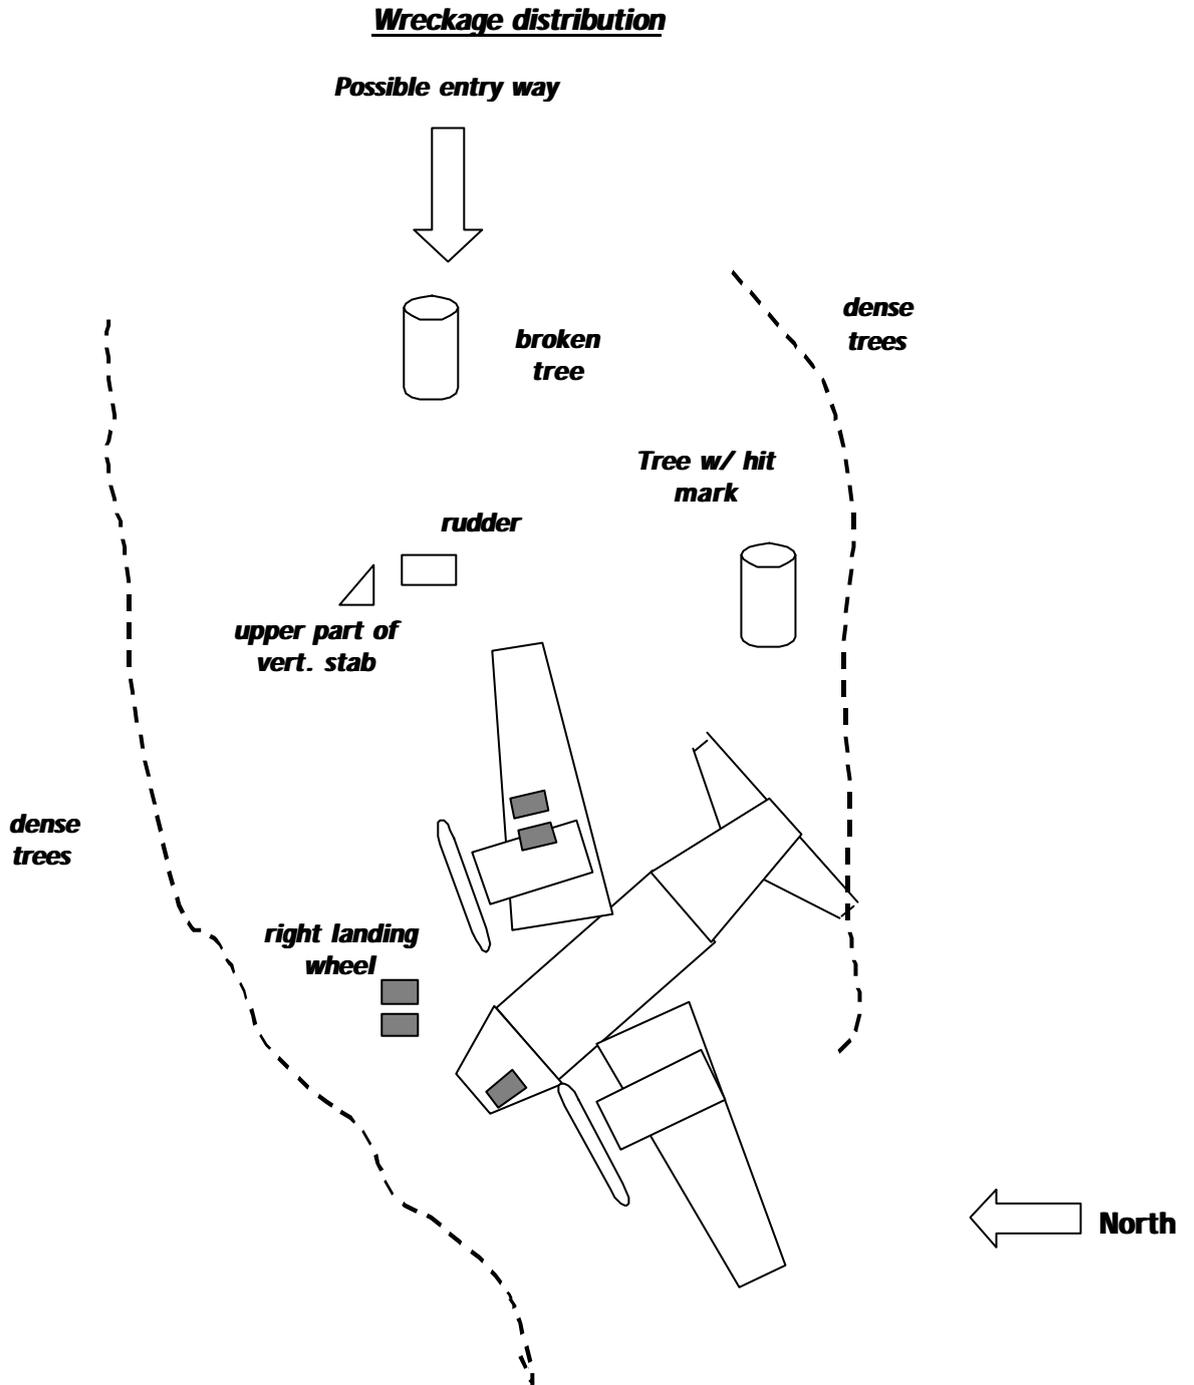
Appendix A. Wreckage and Impact Distribution

The A/C was found upside-down with its nose slightly downward. The left and right wing was ripped out of the fuselage. There are signs of heavy impact damage to left wing leading edge, near the engine pylon. The right wing tip was sheared open and all the fuel has drained out by the time the investigators arrived at the site. The right landing wheel was found near the left engine. The rudder and upper part of the vertical stabilizer were found about 7 meters from the fuselage **(See Appendix A)**. The fuselage was crushed and buckled severely. The right propeller was bent backward.

One of the left propellers was found bent backwards and twisted slightly, while the other was found buried in the ground. To facilitate the evacuation of the crew and passengers, all the seats were taken out from the A/C.

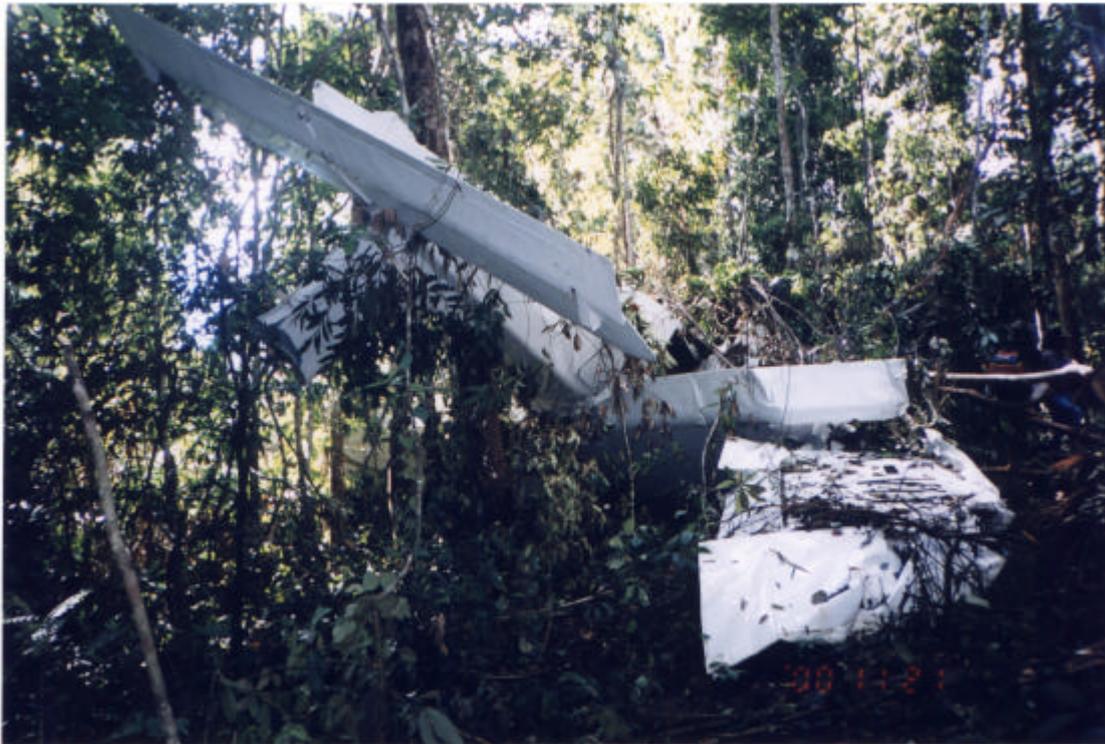
Appendix B. Wreckage and Impact Picture

The A/C was totally destroyed. The left and right wing were found detached and bent severely, with the left landing wheel detached. The rudder and upper part of the vertical stabilizer was detached from the A/C and found nearby. The fuselage was crushed and buckled severely.

The cockpit windows were found broken on impact. There were indications that the front passenger (next to the pilot) door was open before the right wing bending and before the right engine cowling crushed it.

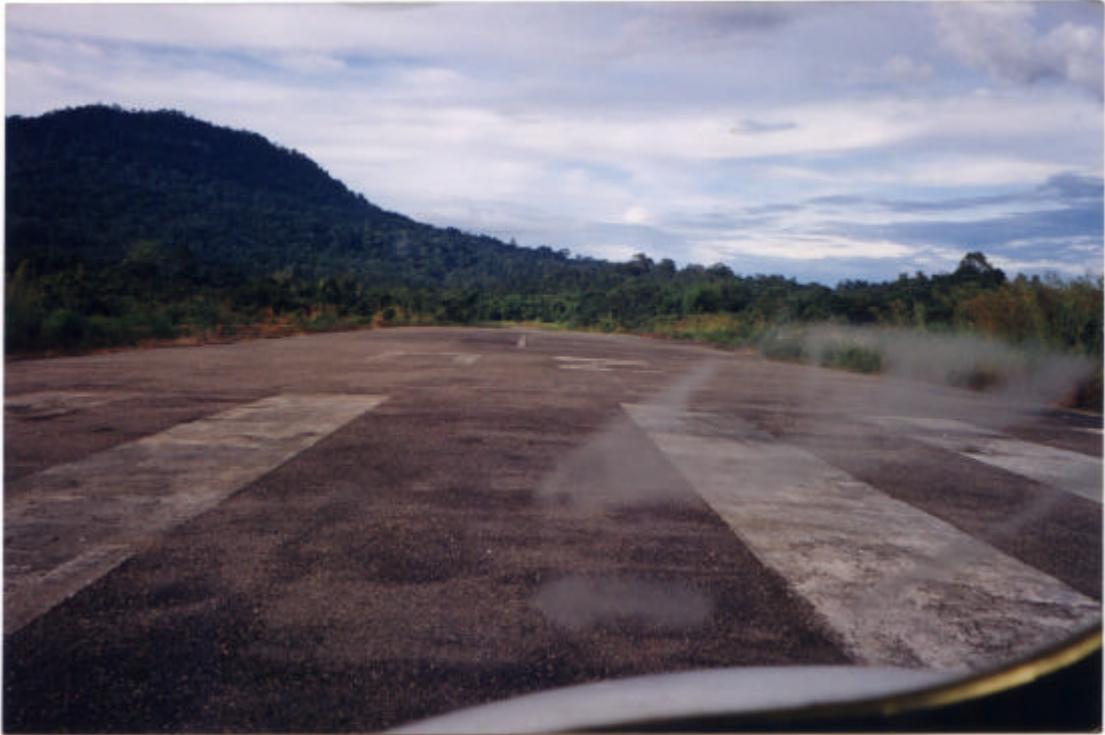
Appendix C. Take off slope Runway 02 Direction

taxiway, but a tower building is not available since the aerodrome is a non controlled aerodrome. The runway is not equipped with landing direction indicators and due to local prevailing surface winds at most of the time, the preferred take off and landing direction is runway 02. A significant obstacle is the hilly forest in the northerly direction of the extension of runway 02. The first obstacle is about 200 feet high above runway elevation located about 533.3 meters from the end of runway 02, and the second obstacle is about 500 feet above runway elevation located 1262.9 meters from the end of runway 02. Runway slope inclination is 3% from direction runway 02. **(See Appendix C)**

This fact confirmed that the aircraft is overloaded. An interview with the PIC revealed that he had a habit of taking-off from Datah Dawai at 70 kts, faster than the A/C recommended take-off speed 55-60 kts. He mentioned that doing so would improve his obstacle clearance performance (**See Appendix C**).

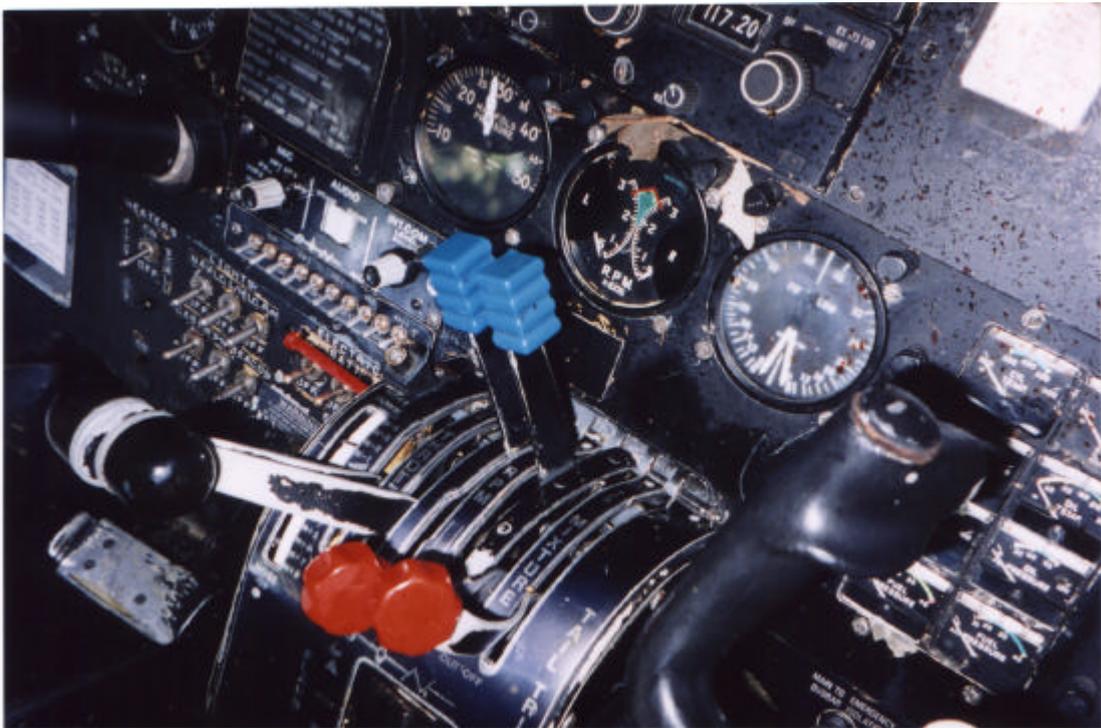
Appendix E. Throttle, mixture, propeller setting after crash

The cockpit examination showed that the throttle positions for both engines were almost closed, mixture positions were closed, the propeller selections were not feathered, and the flap lever was up **(See Appendix E)**. The fuel selectors for both tanks were selected to tip tanks. The directional indicator read 320, which is consistent with the heading of the wreckage. The altitude indicator read 800 ft, the vertical speed indicator read -100 fpm, and the manifold pressure read 27 psi. Meanwhile the fuel press, oil press, and oil temp indicators read 0.

The inspection of the propeller damage indicates that the propellers have very little or no rotation at the time of the impact. This confirms the throttle and mixture setting found in the cockpit, which indicated that most likely that the engines were not running or at very low power at the time of impact. There are three possible causes that may result into engine shut down in flight (**See Appendix E**). Those are engine fire, engine failure, and emergency landing procedure.

Wreckage analysis found no indication of engine fire. The propellers were found in fine pitch and unfeathered position, which indicating improper in-flight engine shutdown procedure. The wreckage indicated that the propeller levers position was not caused by the impact. All the levers on the pedestal were bent to the left due to impact from the right side (**See Appendix A**). It is possible that the pilot may not have time to perform a proper engine shutdown procedure. This and the fact that the settings for both engines were the same indicate that a single engine failure did not occur.
