**KOMITE NASIONAL KESELAMATAN TRANSPORTASI  
REPUBLIC OF INDONESIA**

**Aircraft Serious Incident Investigation Report**

**PT. Lion Mentari Airlines**

**Airbus A330; PK-LEF and Boeing 737-800; PK-LJR**

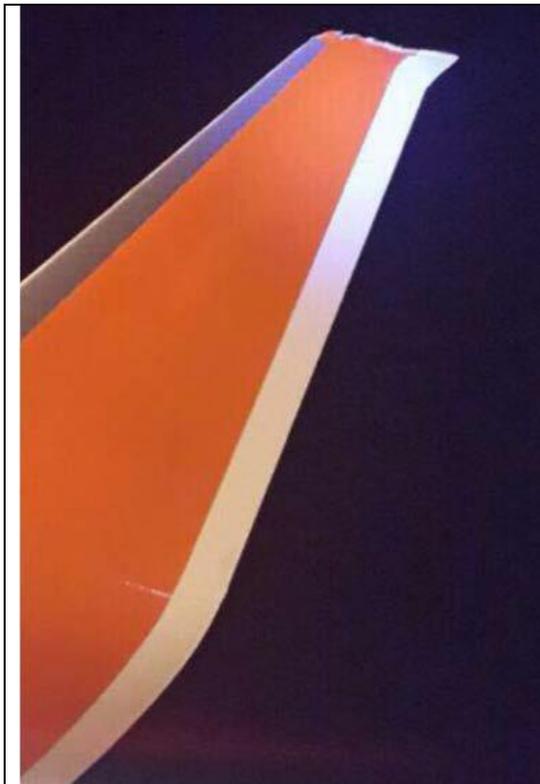
Both aircraft had minor damage. The tip of left winglet of LNI770 was cut off. The lower right wing LNI026 dent and scratch at approximately two meters from the wingtip.

**Figure 2: LNI770 left winglet cut off**

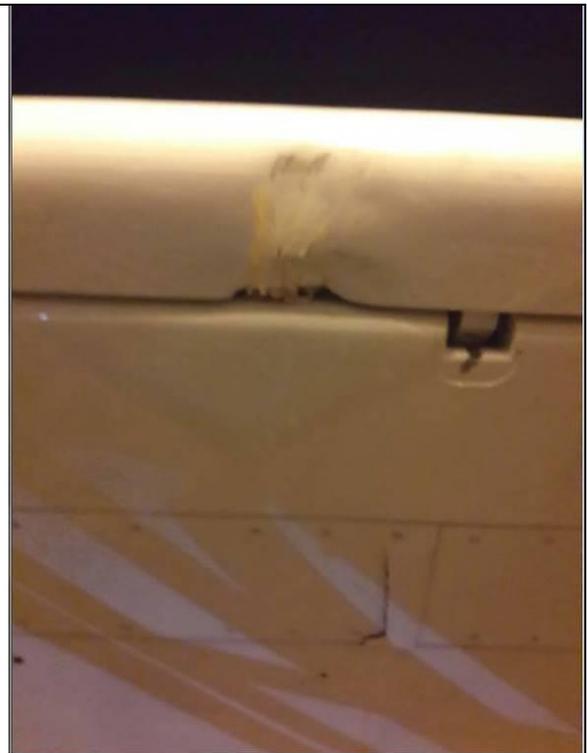
**Figure 3: Dent on the right wing lower surface of LNI026**

Based on the damage of the LNI026 that found scratch about 2 meters from the wing tip, indicated that both aircraft wings overlapping at about 2 meters where the left wing of LNI770 was under the right wing of LNI026. This overlap indicated mis-judgement of the pilot while adjusting the separation.
