**KOMITE NASIONAL KESELAMATAN TRANSPORTASI  
REPUBLIC OF INDONESIA**

## **KNKT.16.34.10.04**

**Aircraft Serious Incident Investigation Report**

**Aero Flyer Institute  
Cessna 172P; PK-HAN  
Cakrabhuwana Airport, Cirebon  
Republic of Indonesia  
13 October 2016**

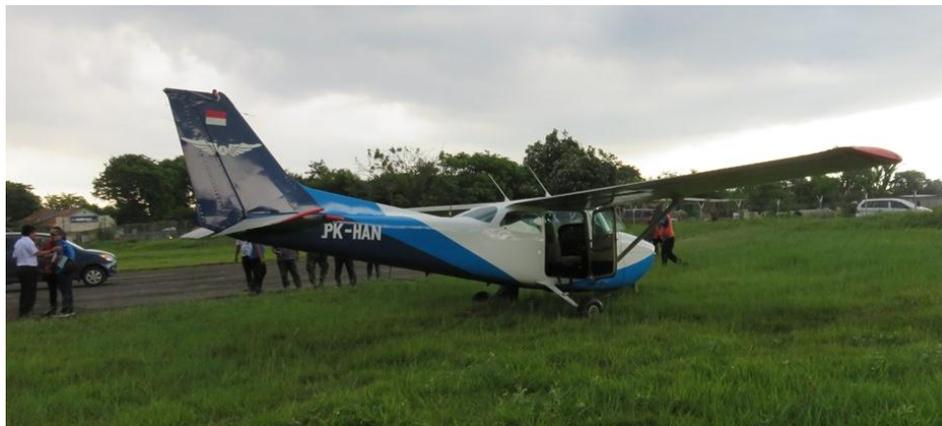
**Figure 2: PK-HAN on the runway shoulder**

The aircraft stop at the right shoulder of the stopway approximately 1,400 meters from the beginning of runway 04.

The instructor and two student pilots evacuated from the aircraft. No damage found to the aircraft and no one injured in this occurrence.

Even though the aircraft landed on the middle of the runway with the flapless, the remaining runway length of Cakrabhuwana Airport was sufficient for the landing performance of Cessna 172P in 8 knots tail wind condition. However, the aircraft stopped at the right shoulder of the stopway approximately 1,400 meters from the beginning of runway 04. The reason of the runway became insufficient was unable to be determined.
