**KOMITE NASIONAL KESELAMATAN TRANSPORTASI  
REPUBLIC OF INDONESIA**

**KNKT.16.04.09.04**

**Aircraft Serious Incident Investigation Report**

**Cessna 172 G, PK-TGL**

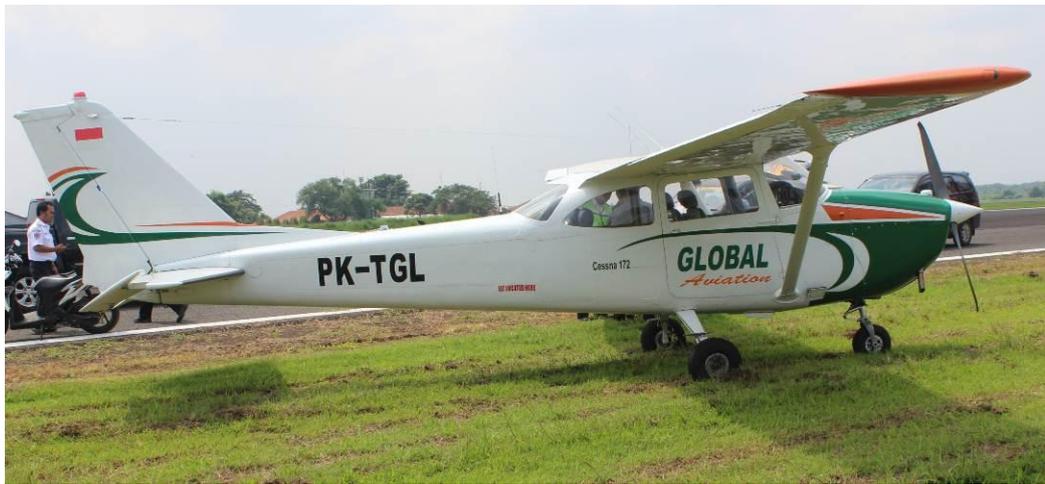
**Figure 1: The last position PK-TGL aircraft after stopped**

The aircraft stopped out on the right of runway 12 with approximately 305 meters from the beginning runway 12 and 23 meters from runway centerline. Investigation found tire marks on the runway surface prior to the aircraft final position.

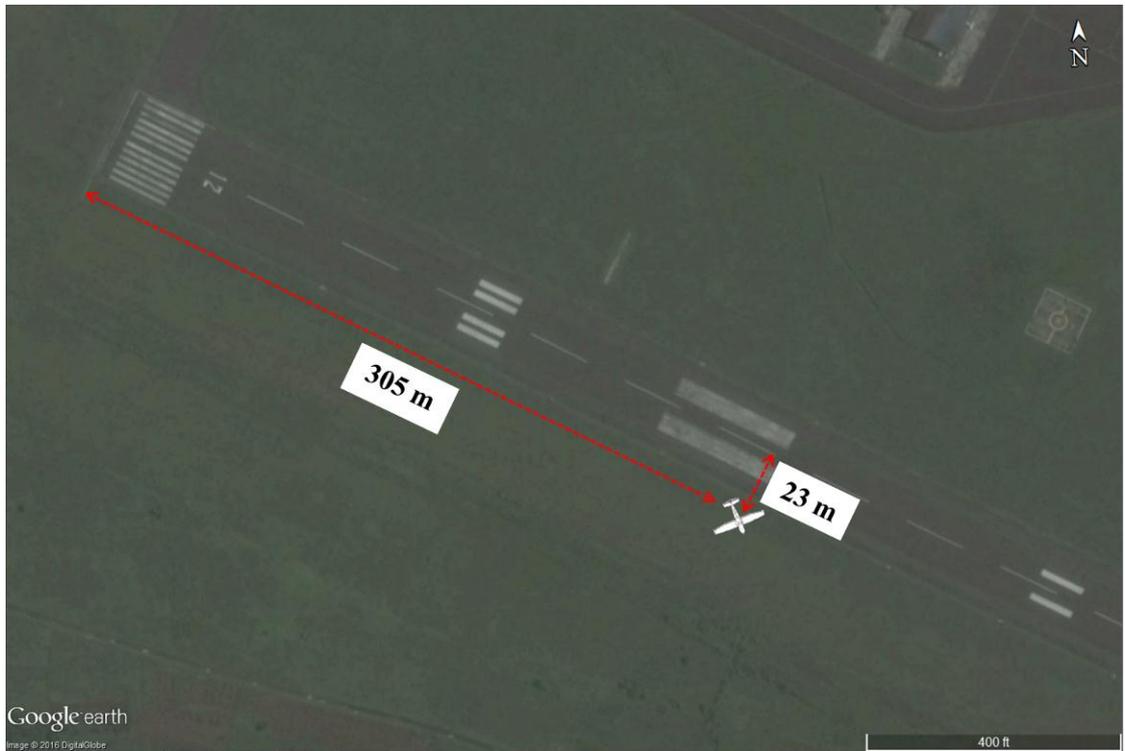
**Figure 2: The illustration of the serious incident site**

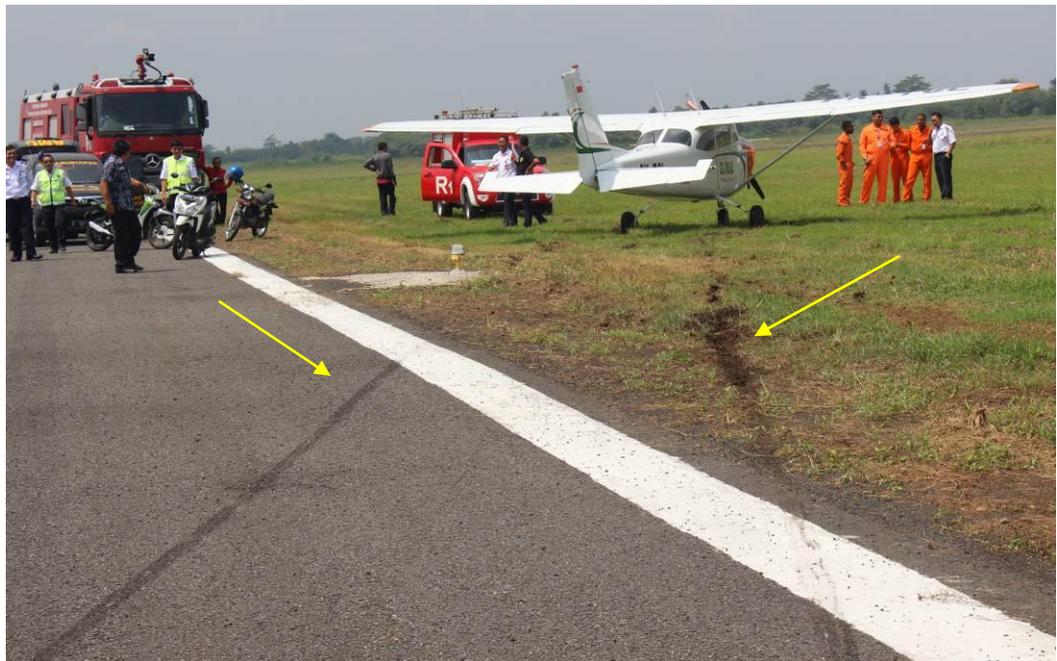
**Figure 3: The wheel marks and aircraft position after stopped**

The tire marks found on the runway prior the aircraft exited the runway pavement indicated that the brake was applied. The tire marks showed the aircraft travelled constantly deviate from the runway. The constant travel to the right might be caused by the yaw effect during the power reduction.

With the aircraft heading was slightly to the right and touched on the right of runway centerline, it shortened the available distance for deceleration. In addition, the delay of the main wheel contacted to the runway resulted in the delay of brake application.

- The aircraft did not align with the final approach path and focusing to regain the directional control of the aircraft had delayed the flare out and lack of the rudder application therefore KNKT recommends to introduce the student pilots with Approach and Landing Accident Reduction (ALAR) training and stabilize approach criteria and to emphasized a go around shall be made when does not meet the criteria.

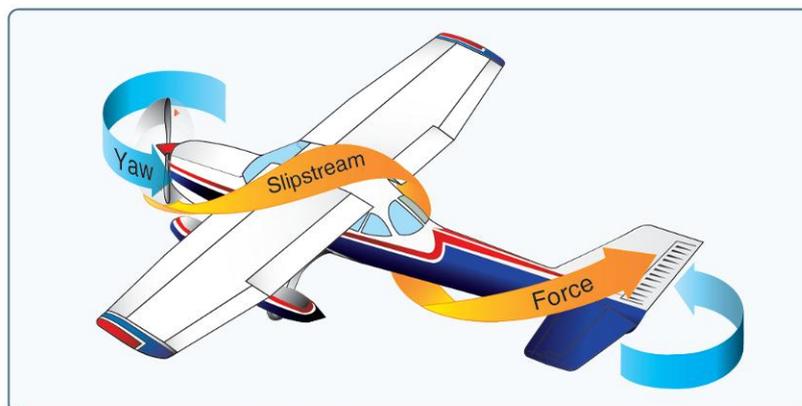
**Figure 5-48.** Corkscrewing slipstream.

The reduced power of the aircraft made the aircraft tend to yaw to the right as a result of the corkscrew effect reduced and required rudder application to eliminate the yaw effect.
