FINAL
KNKT.10.07.13.04

Aircraft Serious Incident Investigation

**PT. Merpati Nusantara Airline
PK-NUH
De Havilland DHC6-300 Twin Otter
Bintuni Airport, Bintuni, West Papua
Republic of Indonesia**

18 July 2010

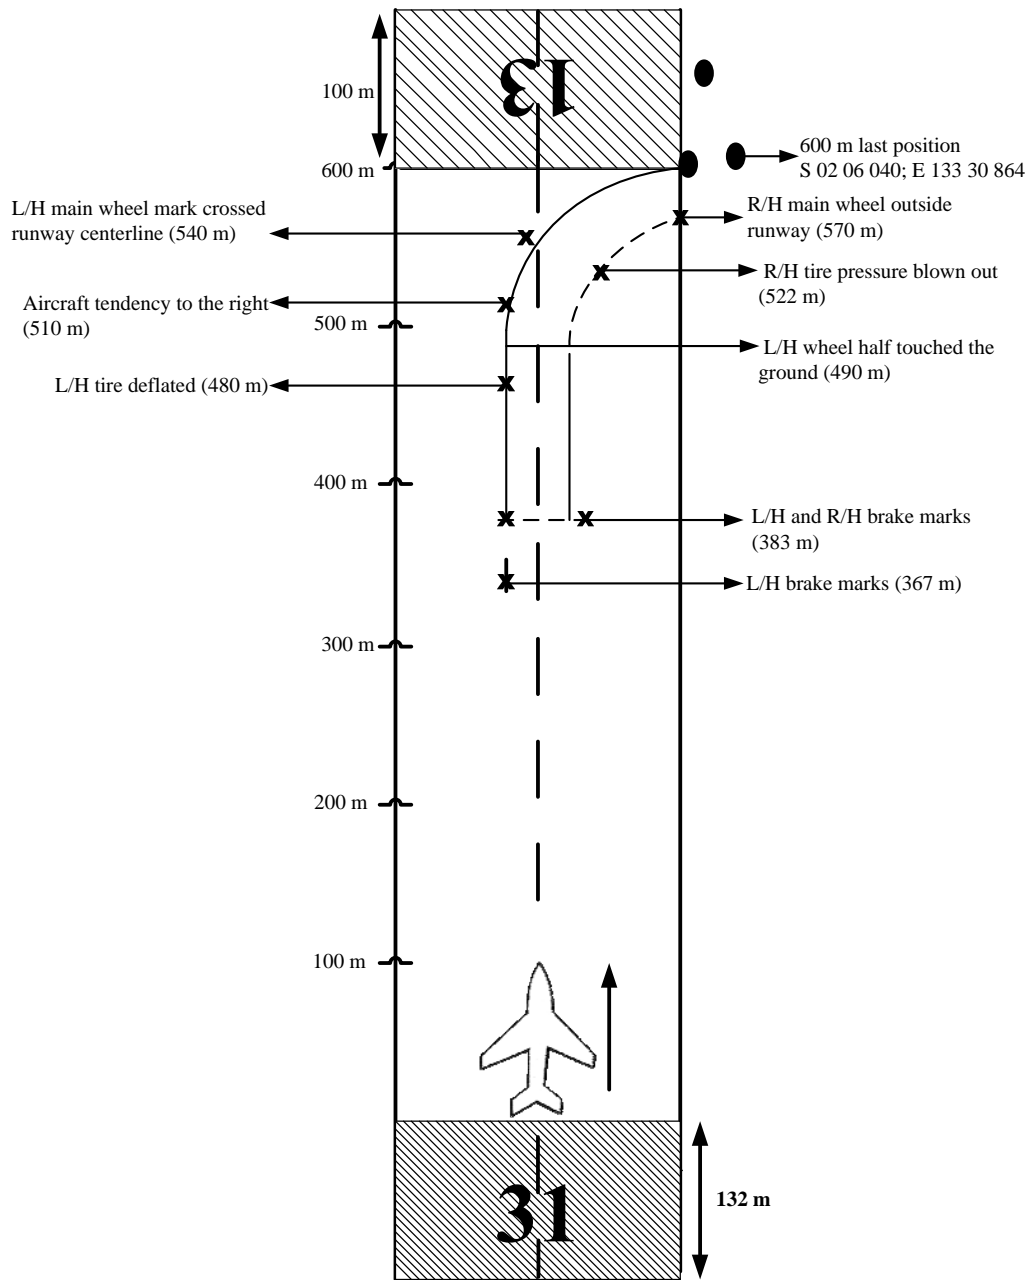
Figure 1: Sketch of serious incident (not for scale)

The aircraft started rolling takeoff at runway 31 at 11.19 LT (02.19 UTC). The co-pilot acted as pilot flying. During the takeoff run, the pilot monitoring (PM) call “Rotate”. One second later the PM call “Fail, fail” as he saw one of the engine torque indicator drop to zero. The pilot flying (PF) then aborted the takeoff by reduced the power lever and continued to reverse.

The aircraft veered to right of the centreline and stopped at the right shoulder at the end of runway 31.

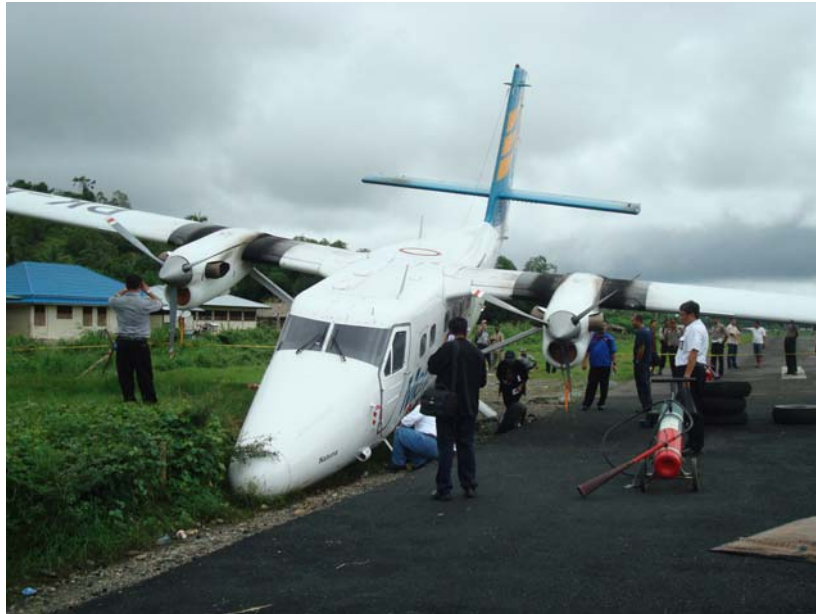
The aircraft has minor damaged. The nose landing gear was collapsed, both main landing gear tires were flat and right foot step was bent.

Figure 2: The aircraft has minor damaged

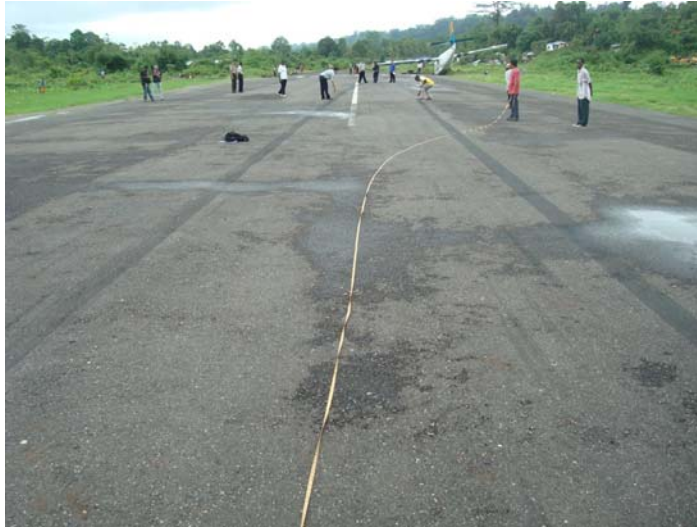
There were marks of tire on the runway that showed the aircraft veered to right during aborted takeoff.

Figure 3: Tire marks on the runway

During the aborted takeoff pilot select the power levers to reverse and applied brake. Mark on the runway showed that heavy breaking was occurred, also indicated in the tire that were flat. These showed that the pilot has applied maximum brake.

Marks on the runway indicated that right main wheel tire was flat prior to the aircraft veered off the right. A flat tire on the right main wheel created drag and might cause the aircraft veered off to the right.
