FINAL
KNKT.07.04.07.04

Aircraft Accident Investigation Report

**Alfa Flying School
PK-SDP
Cessna 172
Nirwana Indah Village, Ciputat, Tangerang
Republic of Indonesia**

7 April 2007

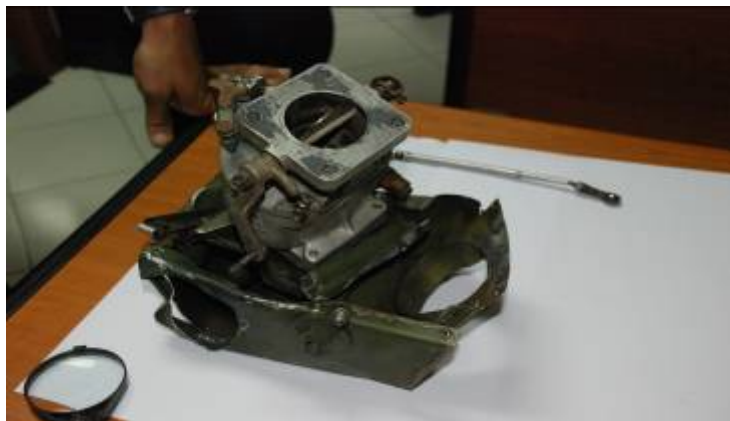
Figure 1: The carburettor ex. PK-SDP

The carburettor inspection found the bolt still attach on throttle arm, without rod end, nut and split pin (**Figure 3Figure 1**).

At the time of writing the Draft Report, the Alfa Flying School had been conducted an inspection to all the aircraft related to the carburettor rod end, nut and split pin attachment in the throttle arm, to assure a proper installation.

The NTSC recommended to the Alfa Flying School should conduct inspection to all the aircraft related to the carburettor rod end, nut and split pin attachment in the throttle arm, to assure a proper installation.

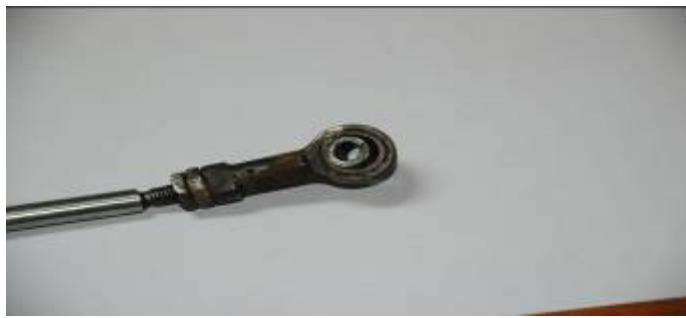
Figure 2: The rod end detached from bolt attachment

The rod end detached from bolt attachment, however, there was not found damaged compulsively (**Figure 2**).

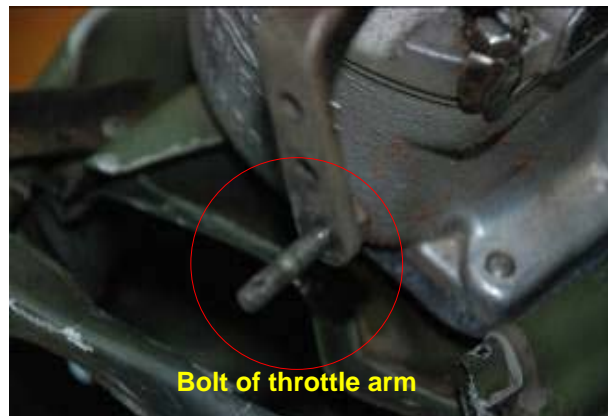
Figure 3: bolt still attach on throttle arm

During investigation, the carburettor found the rod end, nut and split pin were not attached in the throttle arm. These conditions indicated the engine was uncontrolled. The aircraft loss of power caused the butterfly valve malfunction.

The rod end, nut and split pin were not attached in the throttle arm, caused the butterfly valve malfunction following by engine loss power.
