**FINAL**  
KNKT.10.12.18.04

*Aircraft Accident Investigation Report*

**Indonesia Civil Aviation Institute  
Socata TB-10 Tobago; PK-AGM  
Banten Bay, Banten  
Republic of Indonesia**

**1 December 2010**

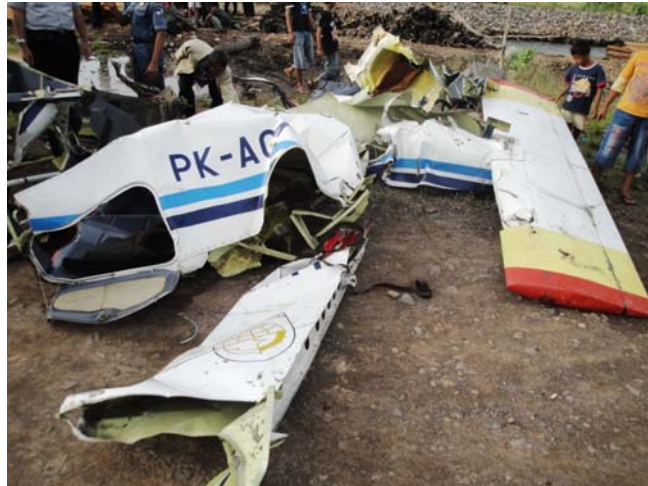
Figure 2: The aircraft wreckage

The aircraft was substantially damage, most likely due to impact with water.

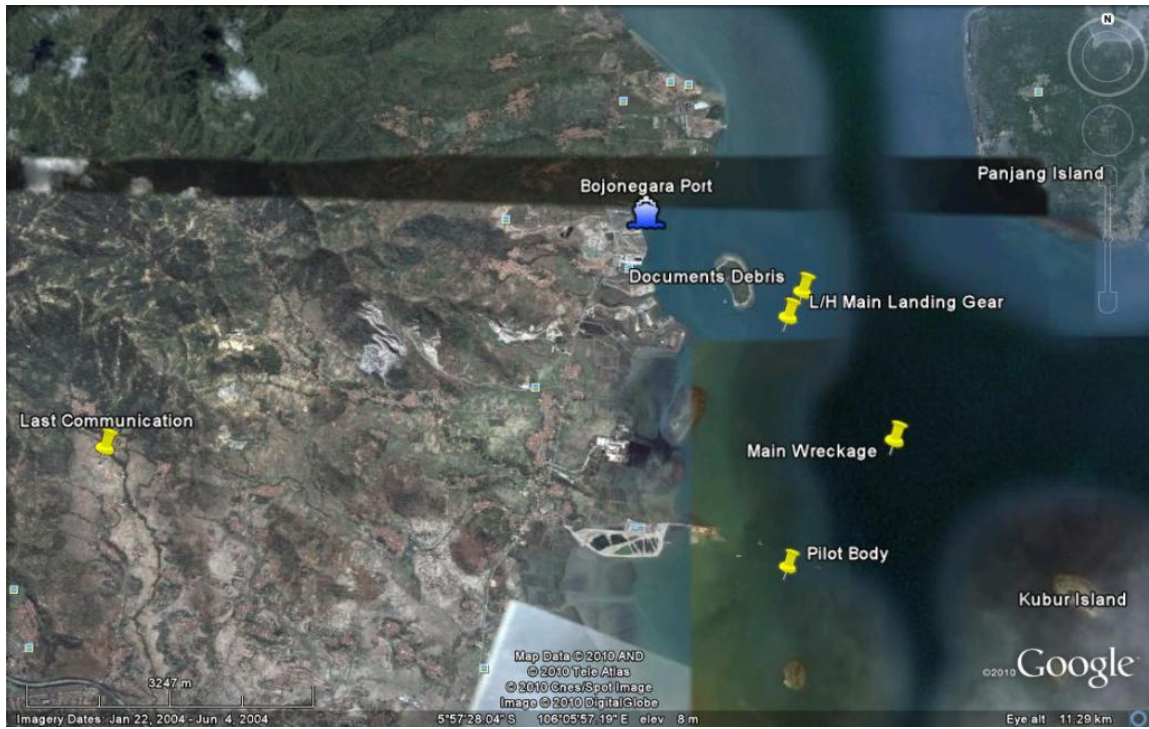
**Figure 3: Wreckage distribution map**

The aircraft wreckage spread about 6 km-square between Panjang Island and Kubur Island on Banten bay. The SAR operation team did not recover propeller, right wing, cockpit instrument panel and nose landing gear.

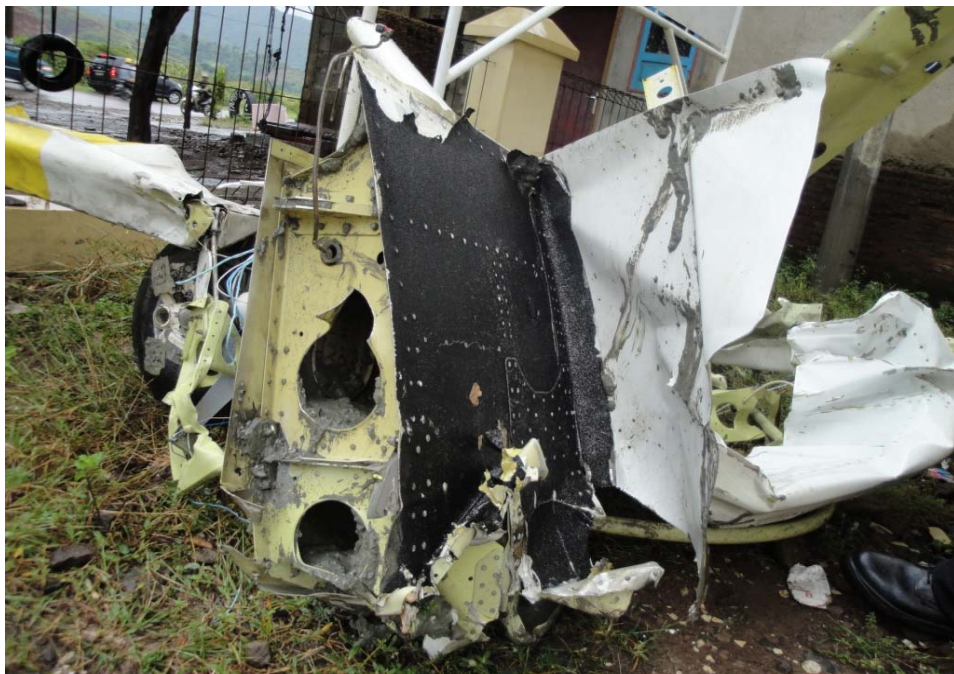
**Figure 4: The left wing root**

The leading edge of the left wing root dent at nearly 90 degrees to the wing spar.

The aircraft was substantially damaged. This indicated that the aircraft impacted with high speed. The recovered wing structure of the left wing root deformed severely at the spar. This indicated that the aircraft impacted at relatively high angle. The high speed and high angle at impact indicated that the aircraft was at a spin dive.

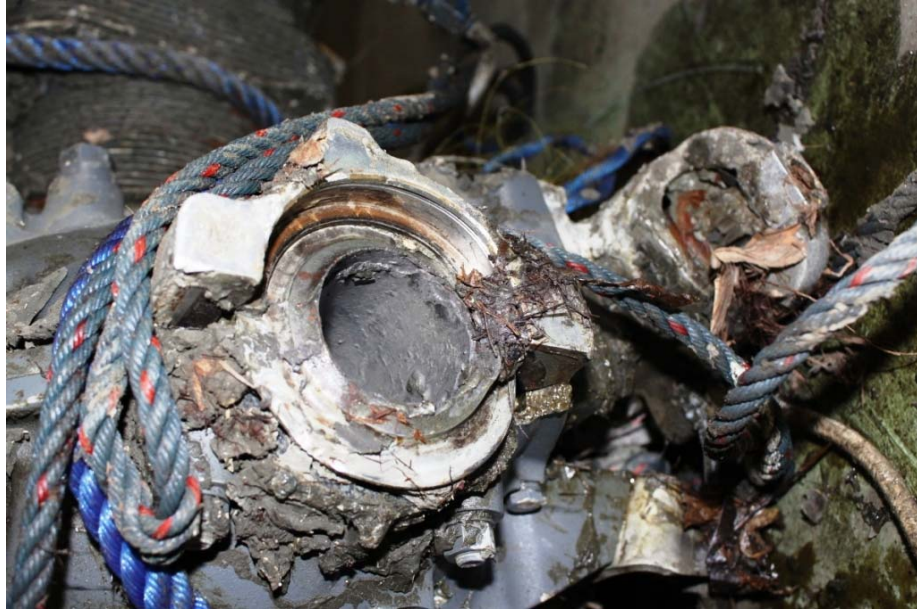
**Figure 5: Broken propeller shaft**

The propeller was detached from its shaft. The propeller shaft was broken at approximately 45 degrees fracture plane. It indicated that the propeller was still powered at the time of impact.

The propeller was detached from its shaft and was still powered at the time of impact. It indicated that the engine was still running at the time of impact.
