**NATIONAL
TRANSPORTATION
SAFETY
COMMITTEE**

Aircraft Accident Investigation Report

**Indonesian Civil Aviation Institute
PK-AGU
Socata Tobago TB-10
Budiarto Airport, Curug
Tangerang, Banten
Republic of Indonesia**

19 April 2010

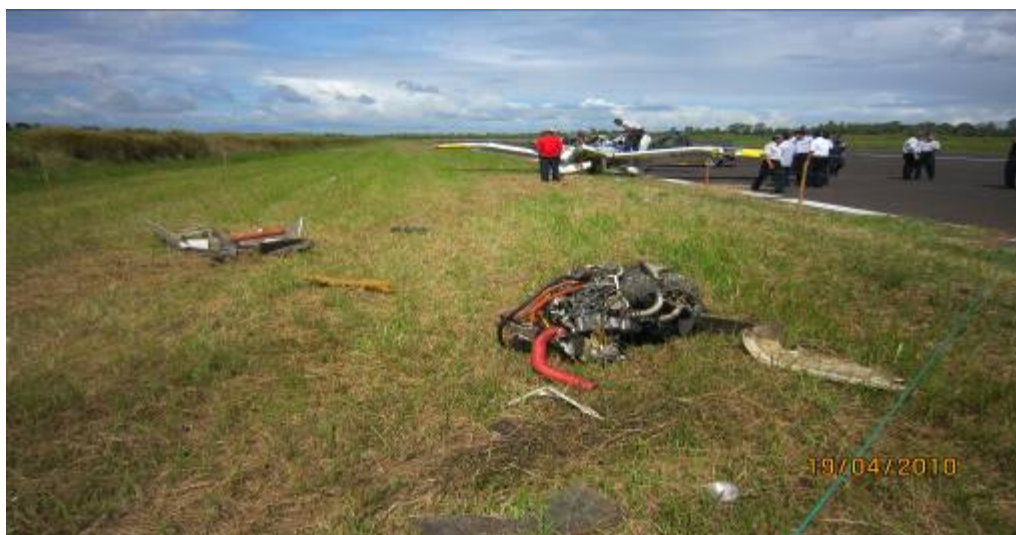
Figure 1: The engine was separated 15 meters from the main wreckage.

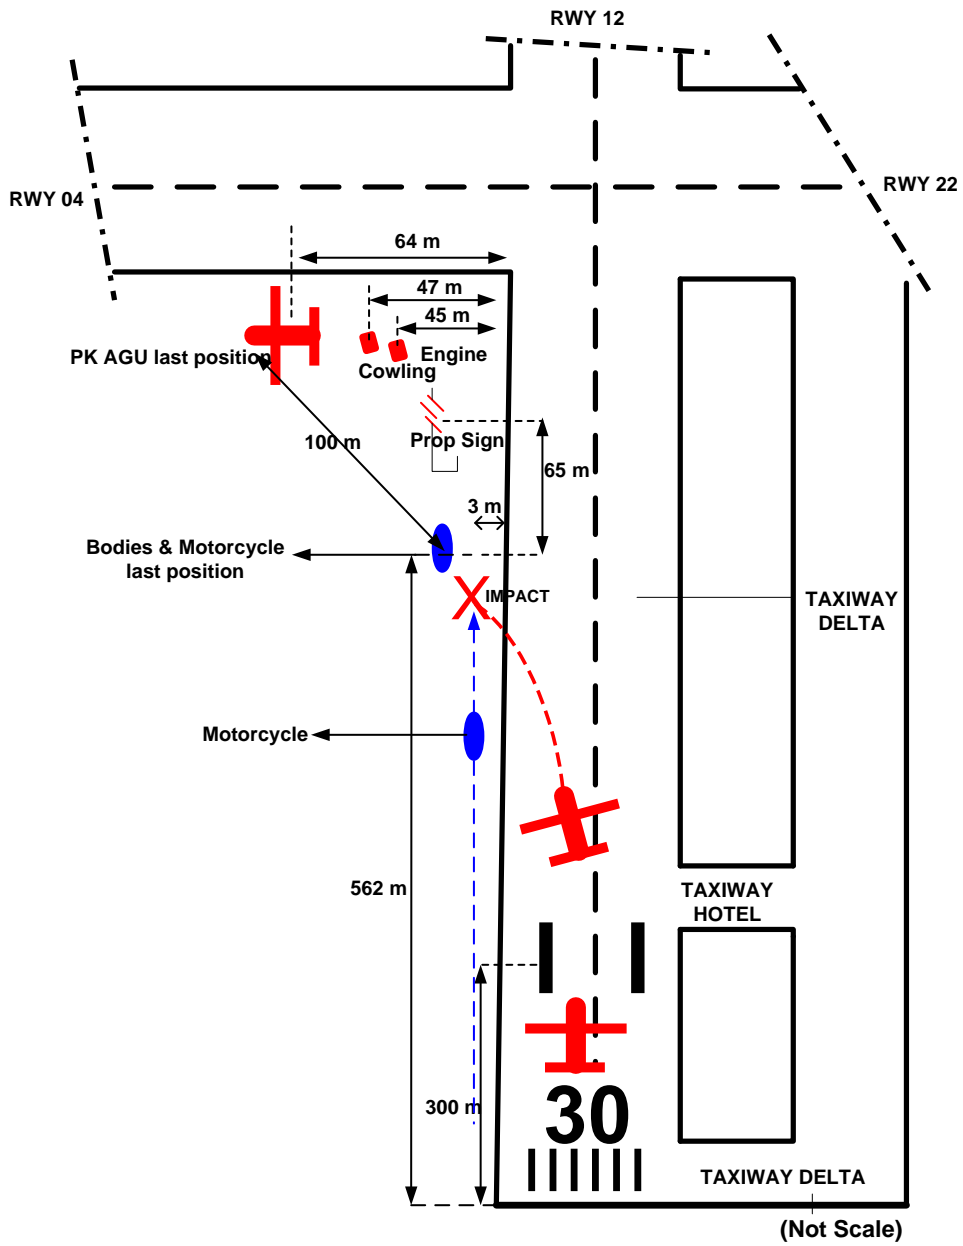
Figure 2: Aircraft Accident Scheme

The aircraft bounced and tend to the left then hit to a running motorcycle on runway. The aircraft overturned to the left side runway 30, 65 meters from runway centerline and 638 meters from beginning of runway 30.

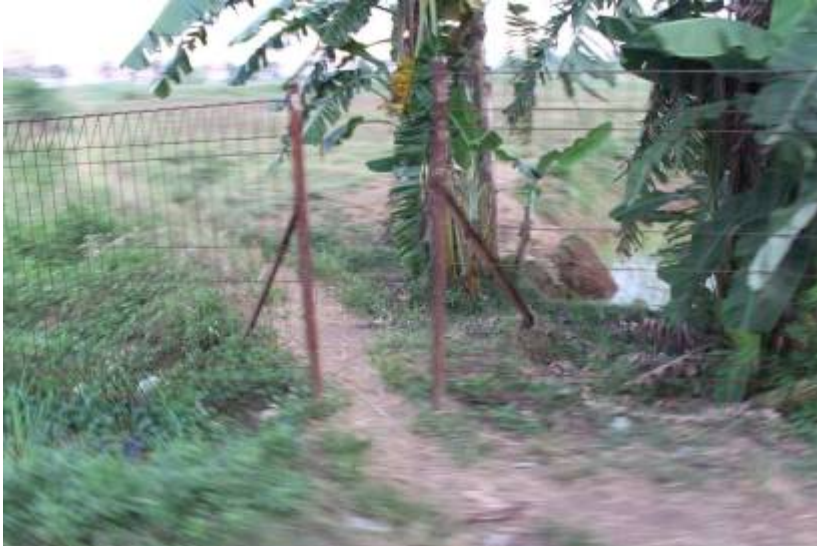
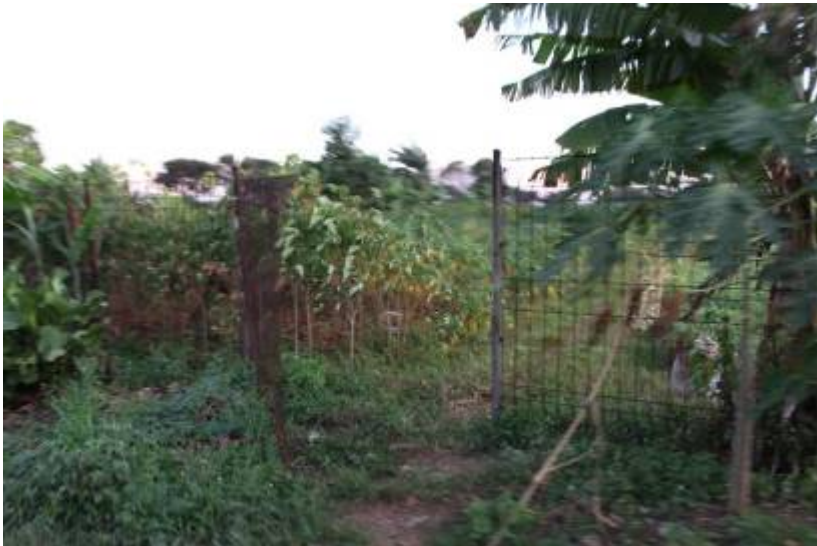
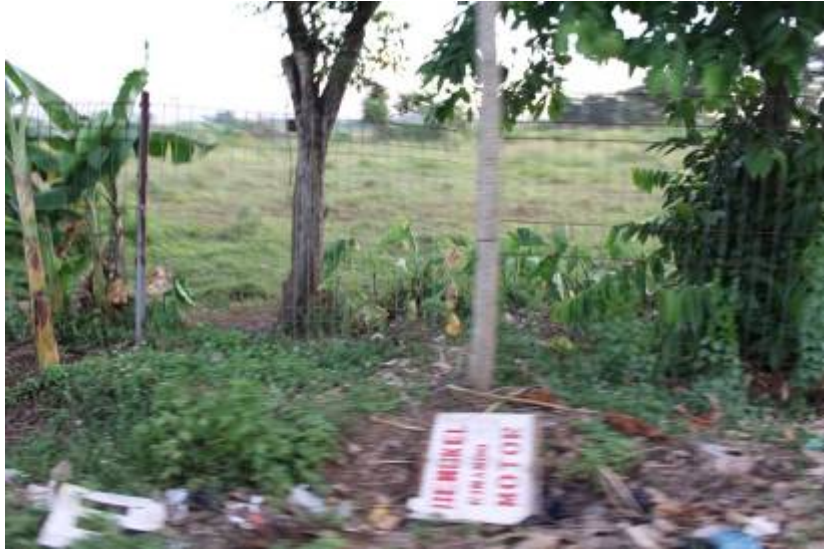
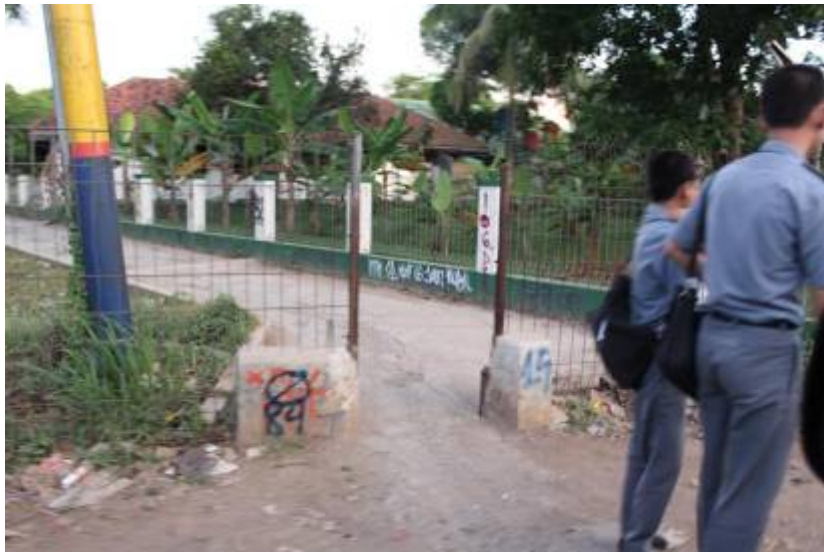
The motorcycle entered the runway through a broken fence

The area outside the airport is a village. The airport perimeter is fenced, but local people breach the fence to enter the runway from the village. The local people used the runway as a shortcut to the main road.

Appendix A: Holes in the fence on the airport perimeter, two days after the accident

- Conducted security coordination between Airport security, STPI's security, local Police, local Army authority, local government, senior local people; and focused in the Airside area security.
- Equipped with fences around the airside area, and maintain secure during operation session.
- Complement the security surrounding runway facilities in the form of a secure boundary fence or to traffic around the runway.
