**NATIONAL
TRANSPORTATION
SAFETY
COMMITTEE**

Aircraft Accident Investigation Report

BEEHCRAFT SUNDOWNER (C23)

PK-ANW

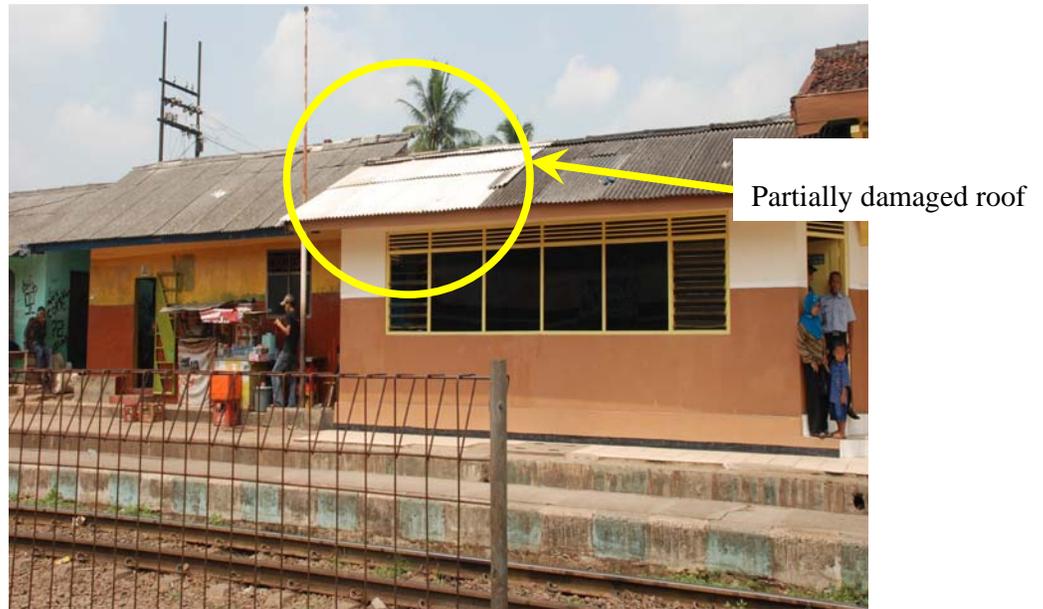
Witnesses reported that during the thunderstorm, high wind blew part of the roof off Tenjo railway station, which was located about 700 meters from the impact site (see Figure 1).

Figure 1: Partially damaged roof at Tenjo railway station

- There were thunderstorms and heavy rain in the vicinity of Curug at the time of the accident.
- High wind associated with the thunderstorm at the time of accident damaged the roof of Tenjo Railway Station, about 700 meters from the accident site.
- The reduction in temperature from 33 degrees Celcius at 0600, to 25 degrees Celcius at 0700, was consistent with cooling resulting from convective downdrafts associated with thunderstorms.
- The air traffic control tower at Curug was not equipped with wind direction and speed indicator displays.
