**FINAL**  
KNKT.11.08.14.04

Aircraft Accident Investigation Report

**PT. Nyaman Air Service**  
**Bell 412; PK-FUG**  
**Dua Saudara Mountain, Bitung,**  
**North Sulawesi**  
**Republic of Indonesia**

**3 August 2011**

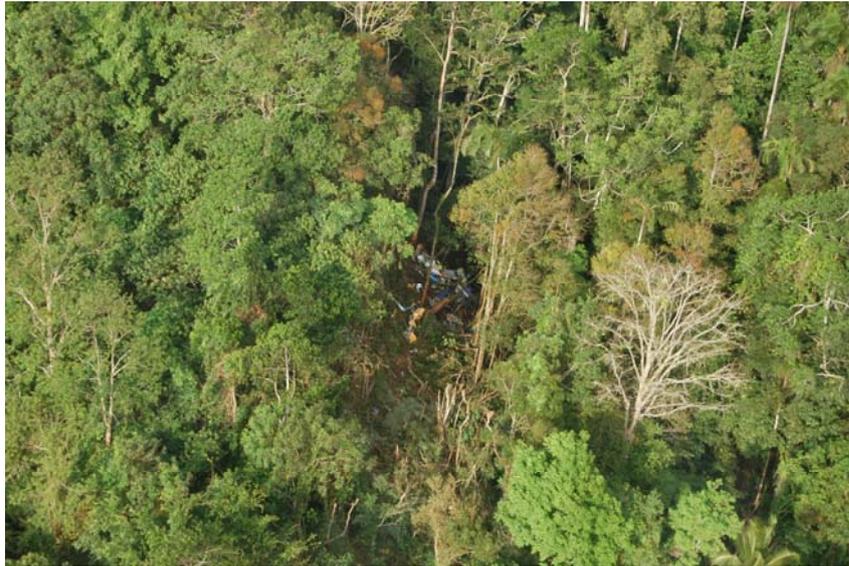
At 1650 UTC the BASARNAS discovered the aircraft wreckage at Mount Dua Saudara at elevation of 2,283 feet at coordinate N 01° 29' 5.6" E 125° 08' 45.8"

Figure 2 : The aerial picture of the accident site.

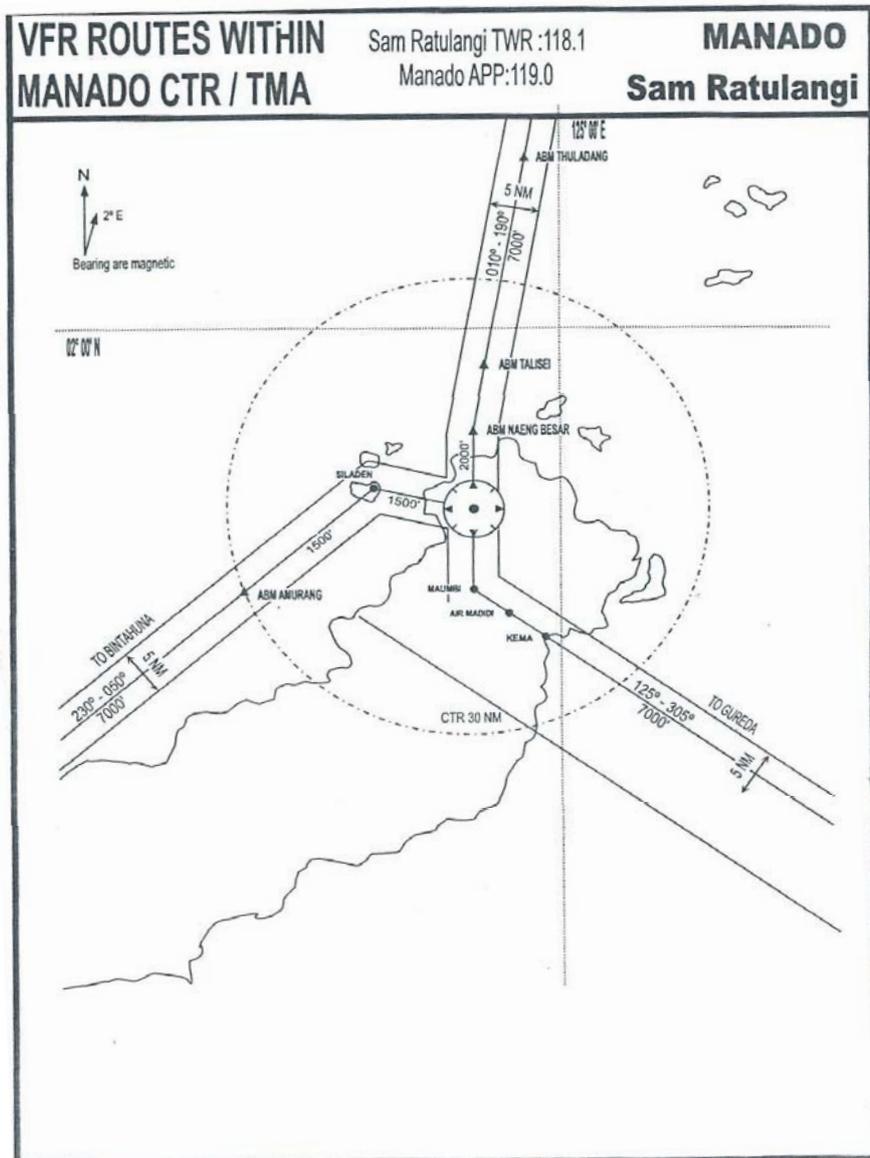
Figure 4. VFR routes guidance within Manado.

The Manado Airport was surrounding by several high terrain. There were 3 routes commonly uses for visual flight as published on a guidance of VFR route. The aircraft flew via the north side of Mount Klabat which was the direct track to Gosowong and did not follow published guidance for VFR.

- To reinforce the flight operation procedure to follow Visual Flight Rules.
- Re-evaluate the single pilot operation for long distance flights particularly for extended overwater operation.
- Ensure to brief pilots with safety briefing more particular ALAR and CFIT prevention.
- Produce “Pilot Guidance” for VFR assigned route for each of operation base/ area, and have it positively controlled. And establish a local VFR procedure for each of operation area/base

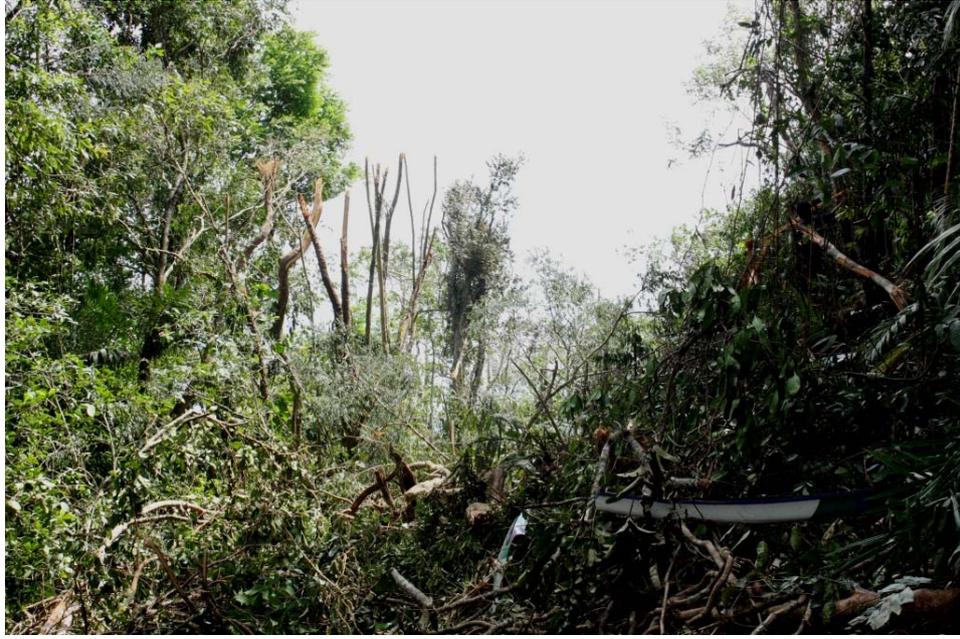
The aircraft was found in the tropical rain forest on Dua Saudara National Park. Prior to impact, the aircraft hit several tree tops. The type of cutting on the tree tops indicating a clean cut, which typical of high speed impact.

**Figure 5: Clean cut on the top of trees prior to impact.**

Prior to the final impact, the aircraft hit several tree tops and resulted to clean cuts. These typical of clean cutting were caused by a high speed impact. In this particular accident, most likely this caused by high energy of main rotor blade rotation. This high energy could be produce only by powered engines.

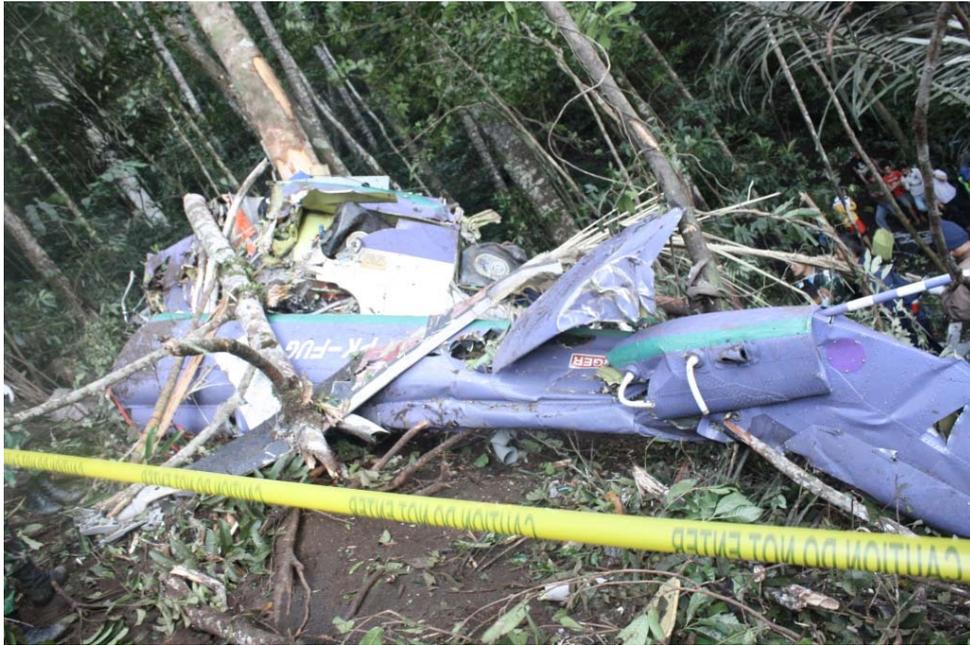
Prior to its final position, the aircraft has impacted and collapsing at least 4 significant size trees. The main wreckage leaned on another big tree.

**Figure 6: Aircraft final position**

Prior to the final impact, the aircraft also collapsed several significant sizes of trees. In order to collapse several big trees, it requires high forces. The high forces could be result from high aircraft speed.

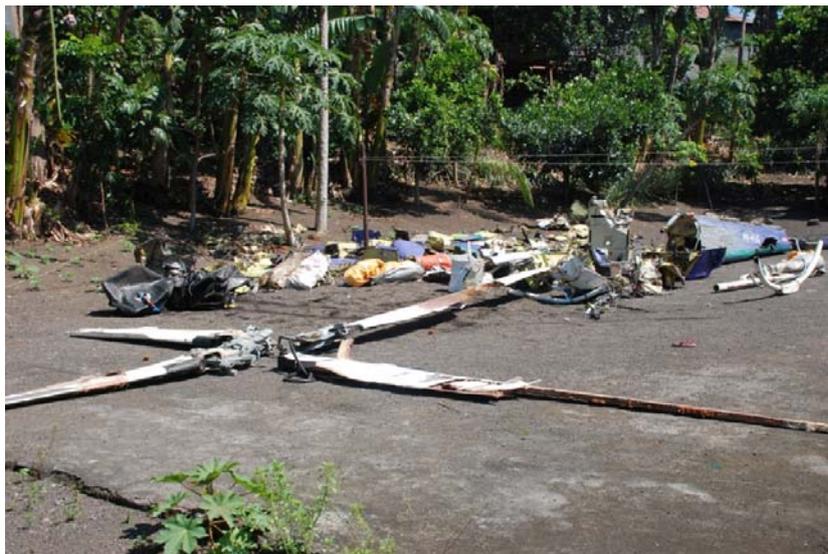
The examination found that the tail rotor shaft twisted, this indicated that the tail rotor shaft was rotating on impact. The examination concluded that the engine and flight control were functioning properly prior to impact. The result of this examination is attached in the appendix.

**Figure 7: Examination of the wreckage.**

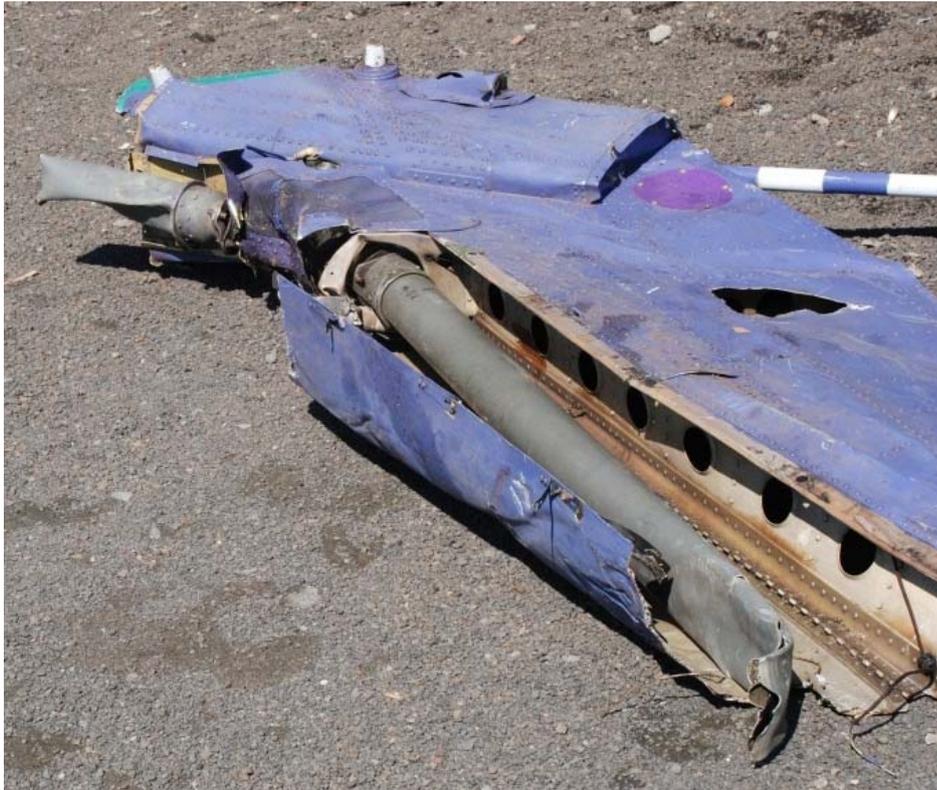
**Figure 8: Twisted tail rotor shaft**

The examination found that the tail rotor shaft twisted, this indicated that the tail rotor shaft was rotating on impact. The examination concluded that the engine, main and tail rotors were functioning properly prior to impact.

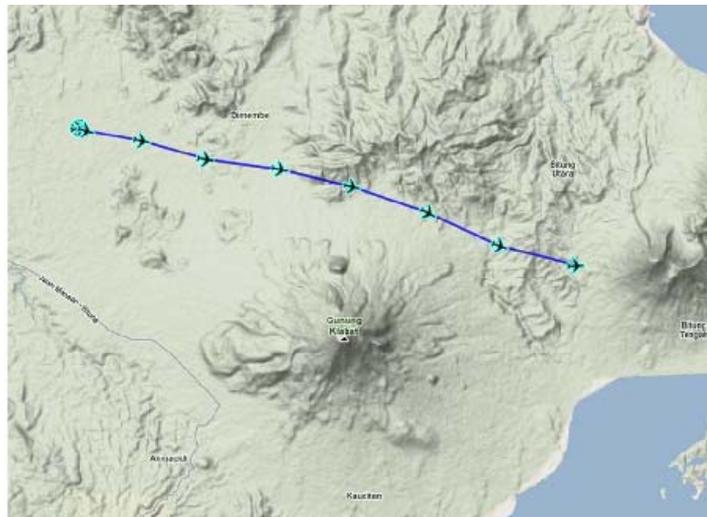
**Figure 8: The aircraft PK-FUG accident route recorded in the Skynet.**

The skynet recorded that the aircraft flew direct track to Gosowong. This direct track was very common used by Nyaman Air pilots. This route was chosen to shorten the flight time. Nyaman air did not have route guidance for this direct track.
