KNKT.07.04.08.04

*Aircraft Accident Investigation Report*

**PT. Garuda Indonesia  
PK – GWK  
Boeing Company 737-400  
Soekarno-Hatta Airport, Jakarta  
Republic of Indonesia**

**12 April 2007**

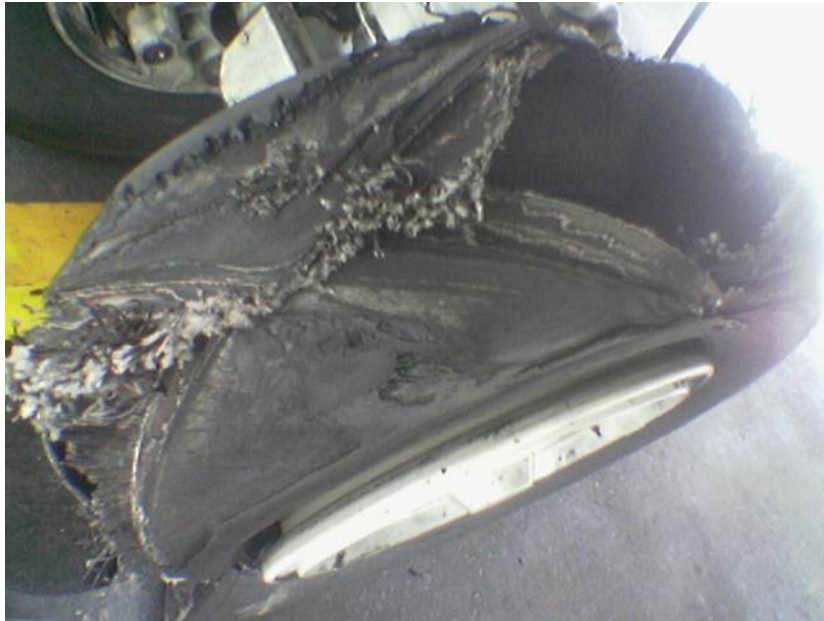
The number-two tire of the main landing gear was burst and the thread was detached (Figure 1). The burst was an “X” type.

Figure 1: The number-two tire burst.

- The tire shows “X” type damage. This type of damage indicated that a pointed object was rolled over by the tire and burst forming a “X” type damage to the thread.
- The pointed object could be one of broken pieces of concrete found on the runway.
- The burst resulted the thread peel off.
- The debris (tire pieces and / or concrete) hit and damaged the aft left flap tearing through the flap thickness.

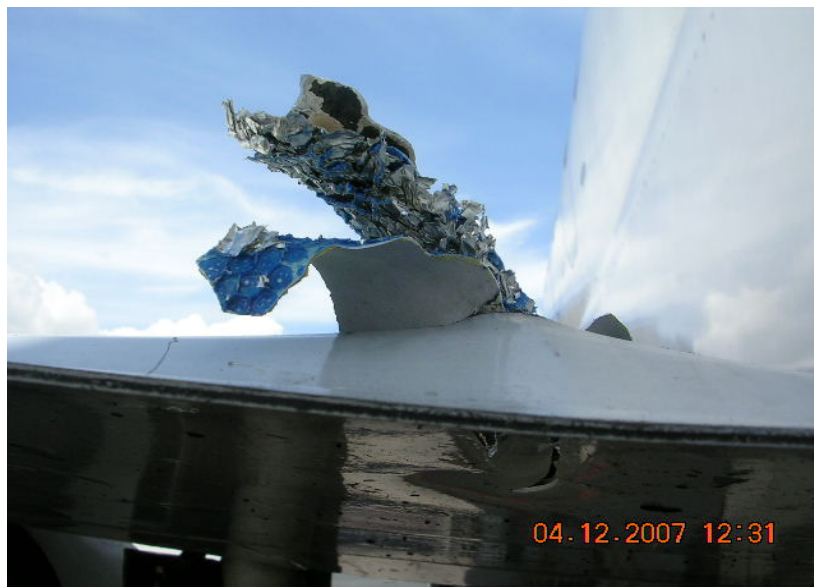
The aft flap was damaged as shown in Figure 2.

Figure 2: The damage at the aft flap.

- The “X” form of damage indicated that a pointed object was rolled over by the tire causing tire burst. The pointed object could be one of the broken pieces of concrete.
- The tire burst peeled off the thread. The broken pieces of concrete and/ or the tire hit and damaged the left aft flap tearing through the flap thickness.

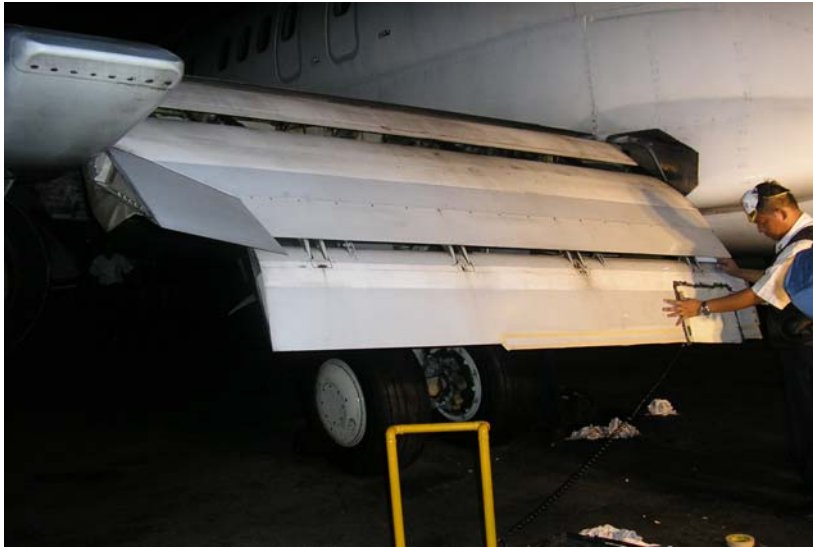
Figure 3: The damaged aft flap after repair

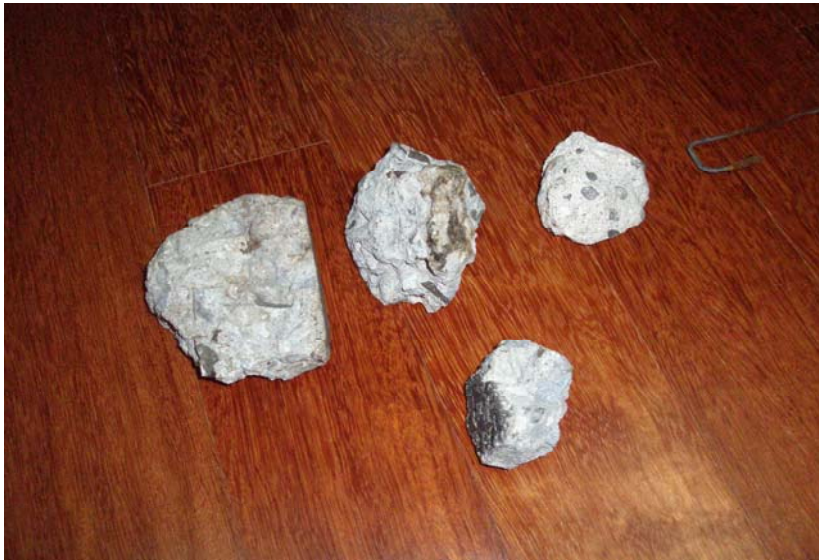
The night at 11 April 2007, the concrete runway surface 25R was repaired used asphalt. Early in the morning, the runway was cleaned used a sweeper truck.

Several broken pieces of concrete were found on the shoulder of runway 25R after accident (Figure 4).

Figure 4: Broken pieces of concrete found on the runway.

At the time of the accident there was a repair on the runway. Moreover, broken pieces of concrete were found.

- maintain and ensured the cleanliness of the runway in accordance with applicable rules and regulations.
- repair of the runway should be done in accordance with the approved methods.

- Ensure the cleanliness of the runway in accordance with applicable rules and regulations.
- Ensure the repair of the runway should be done in accordance with the approve method.

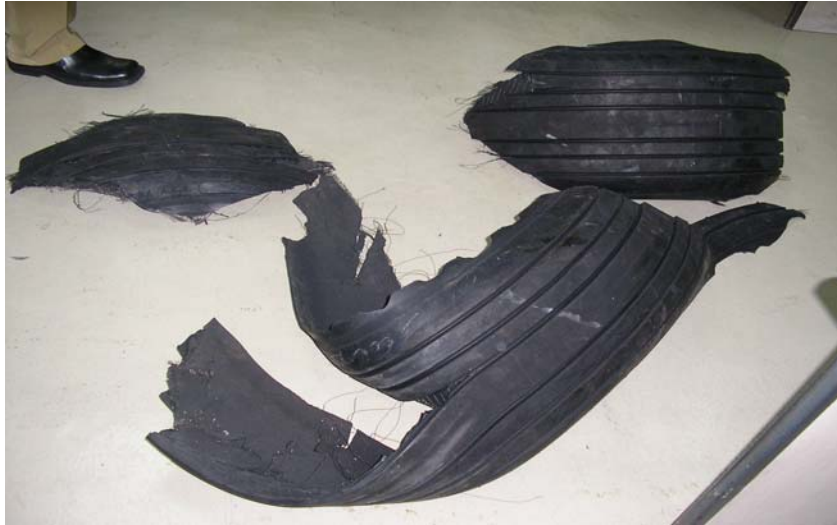
Several debris of the tire burst found on the runway 25R of the Soekarno-Hatta International Airport, Jakarta.

Figure 5: The tire debris.
