**NATIONAL
TRANSPORTATION
SAFETY
COMMITTEE**

Aircraft Accident Investigation Report

**Aero Flyer Institute
Cessna 172 ; PK-HAF
Cakrabhuwana Airport, Cirebon, West Java
Republic of Indonesia**

4 March 2011

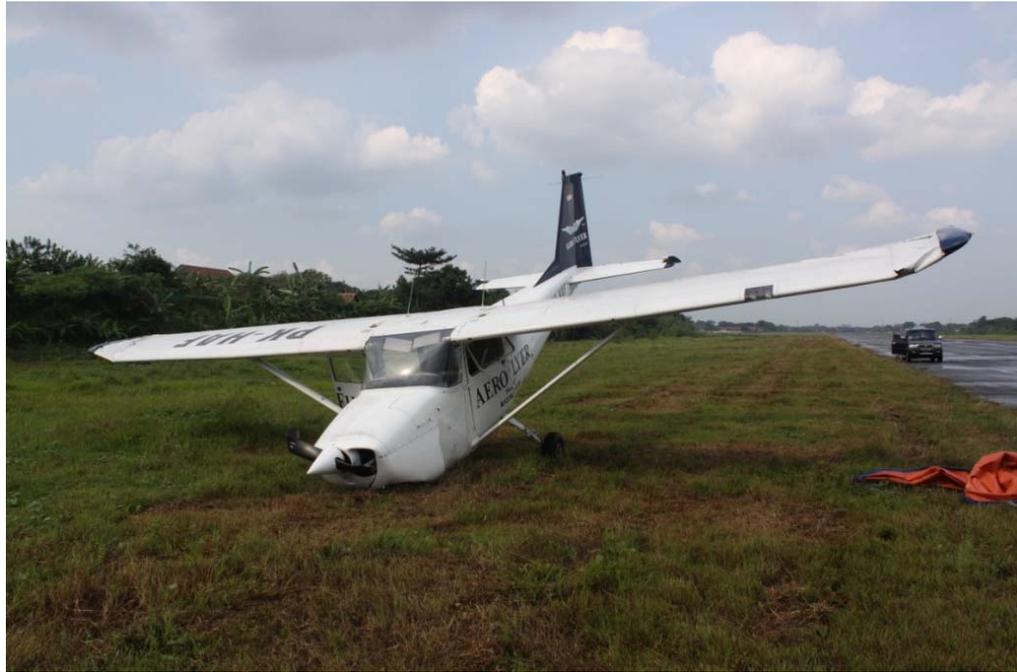
Figure 1: The last aircraft position

The aircraft veered to the left and out of the runway, the aircraft stopped on left shoulder opposite the landing direction runway 04, at the coordinate of 6° 44' 11" S 108° 33' 50" E.

The aircraft stopped on left shoulder about 23 meters from runway centreline and 165 meters from beginning runway 04 with the aircraft heading opposite the landing direction runway 04. There was a paint mark indicated of the first impact of the left wing tip to the runway.

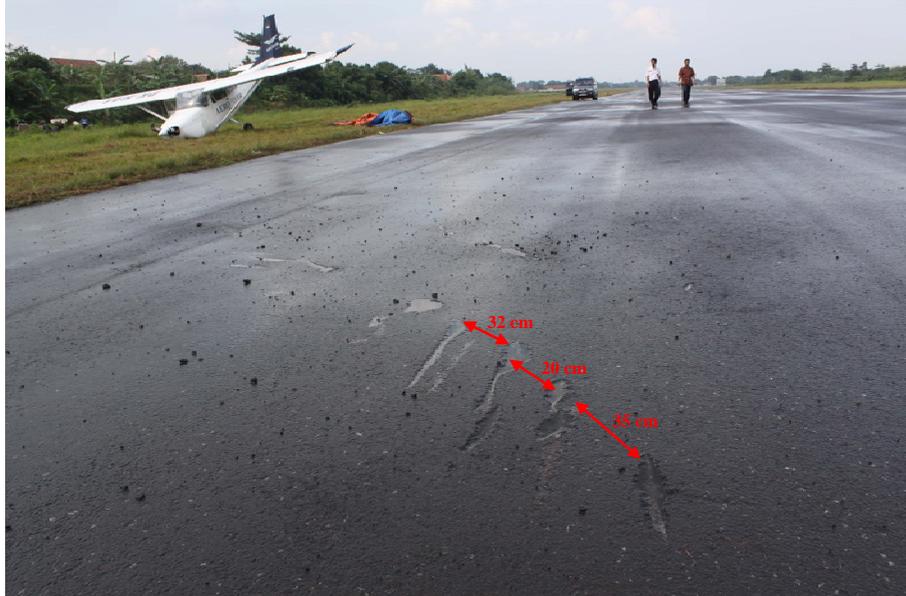
Figure 2: Scratch on the runway surface

The runway surface was scratched at the propeller impact point.

The scratch mark was found on the runway 04.

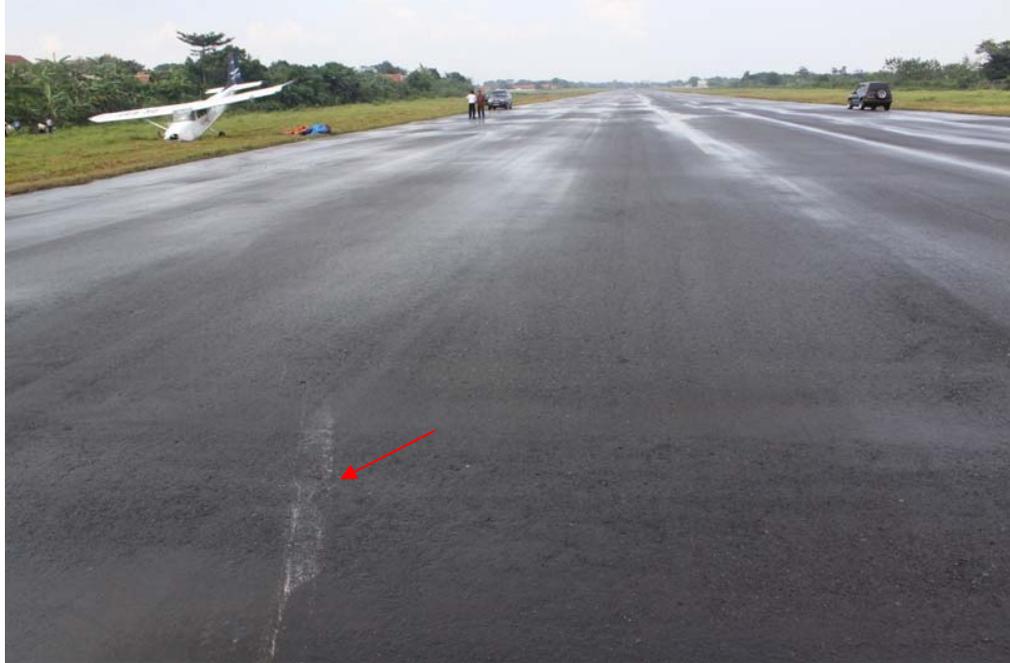
Figure 3: The left wing tip paint mark

During go around the aircraft was banking to the left, and then the left wing impacted the runway followed by propeller and nose wheel.
