KNKT.11.03.09.04

Aircraft Accident Investigation Report

**Aero Flyer Institute
Cessna 172 ; PK-HAI
Cakrabhuwana Airport, Cirebon, West Java
Republic of Indonesia**

12 March 2011

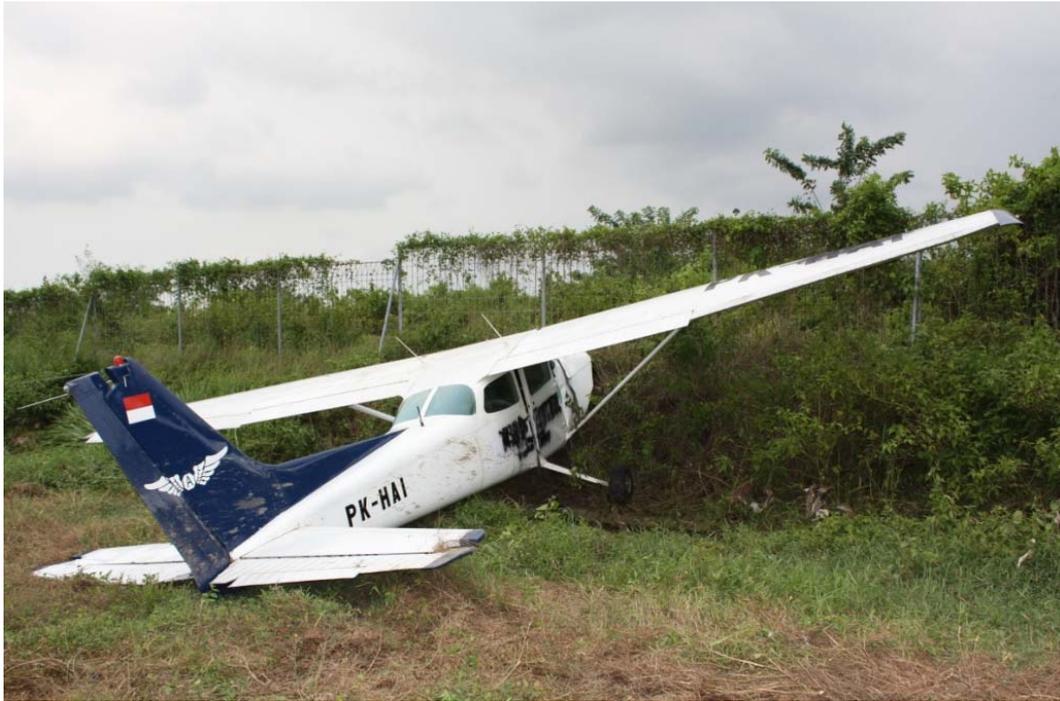
Figure 1: The last aircraft position

During take-off roll about 235 meters from the beginning runway 04, the aircraft moved to the left starting from the blue mark of paint on the runway. After the aircraft nose pitched up and veered to the right, the aircraft bounced twice on the grass. The aircraft finally stopped by impacting a cliff about 60 meters from the runway centreline and 530 meters from beginning runway 04.

The final direction of aircraft was about 140 degrees, and coordinate 6° 45' 20" S 108° 32' 36" E.

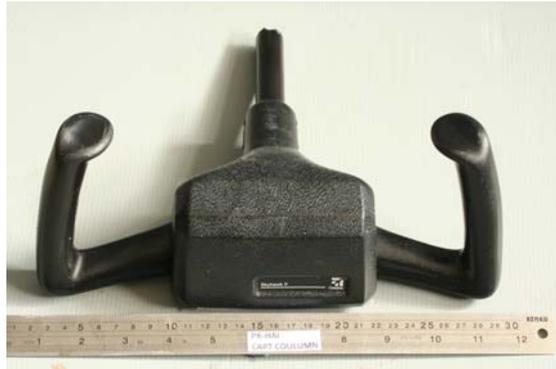
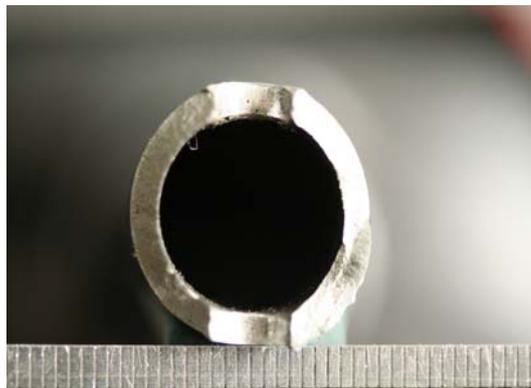
The forward and twisted force caused the left yoke shaft was broken at the pin hole.

Examination of the failed left yoke control shaft indicated a fresh overstress failure due to a sudden bending force on the left yoke at the point where the control lock pin is inserted.

Figure 2: The broken Left yoke.

Figure 3: Failure on the left yoke control shaft.

The student pilot's yoke had failed in overstress indicating a sudden force on the left yoke at the point where the control lock pin is inserted.

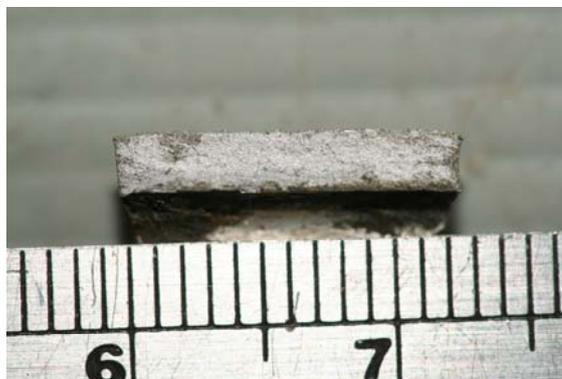
Figure 4: The broken forward bushing-seat stop

An examination of the instructor's seat locking pin showed that it had not been secured correctly in the seat track.

An examination of the failed instructor's right bushing-seat front stop indicated a fresh overstress failure as a result of contact by the seat when the aircraft impacted the cliff (Figure 4).

The right pilot's bushing-seat front stop track failure indicated a shear force as a result of the seat forward movement when the aircraft stopped suddenly.

The instructor's seat had not been secured correctly prior to the takeoff.

The National Transportation Safety Committee recommends that the Aero Flyer Institute to ensure the pilot to check and re-check the security locked within seating.
