**NATIONAL
TRANSPORTATION
SAFETY
COMMITTEE**

AIRCRAFT ACCIDENT REPORT

PT. Lion Air

Boeing 737-200 PK-LID

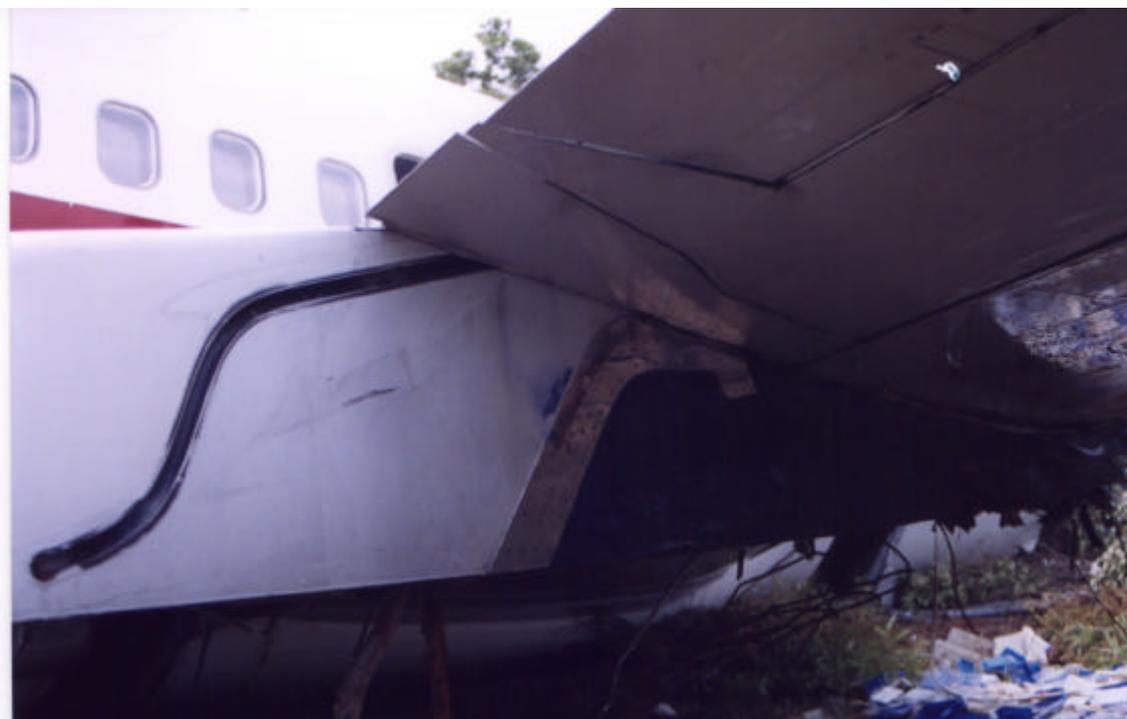
The LH and RH flap were found stowed. Inspection of the flap ball nut number 4 and 5 confirmed that the flap is at zero position (touching the up position). Left wing leading edge # 1 slat measured 3/8-inch gap between leading edge and fixed wing. Right wing leading edge were damage extensively. The leading edge actuator number 8 hydraulics tubes severed. Actuator was visible and was in a retracted position.

Flap position of the RH wing

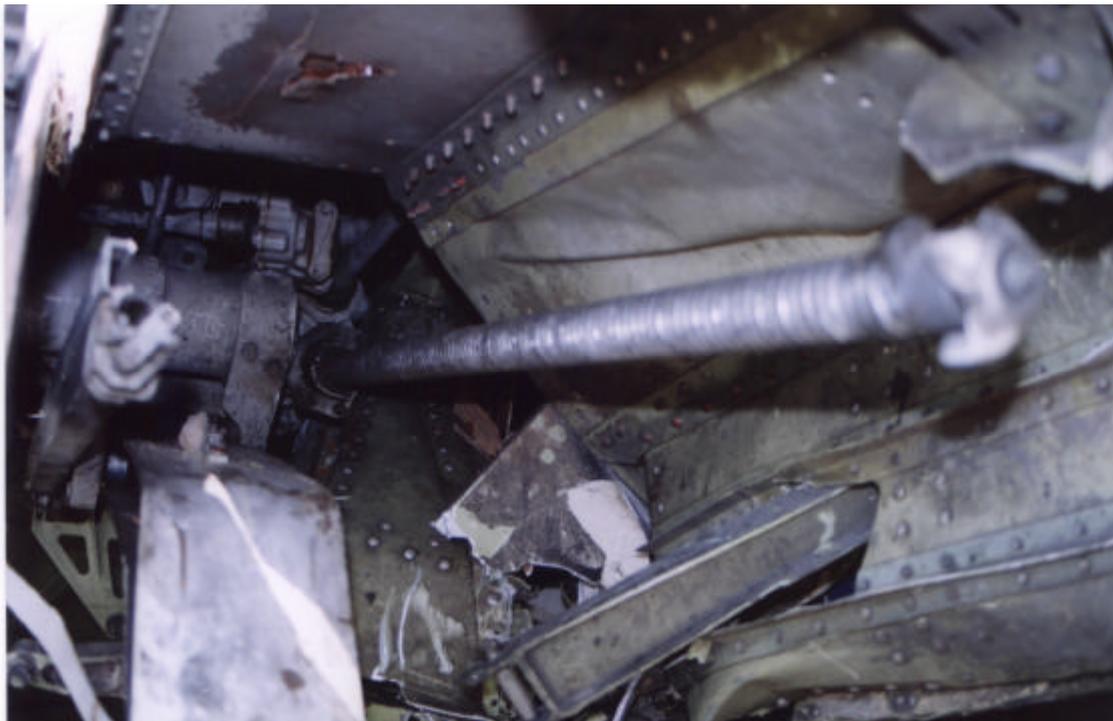
Flap screw jack of the LH wing

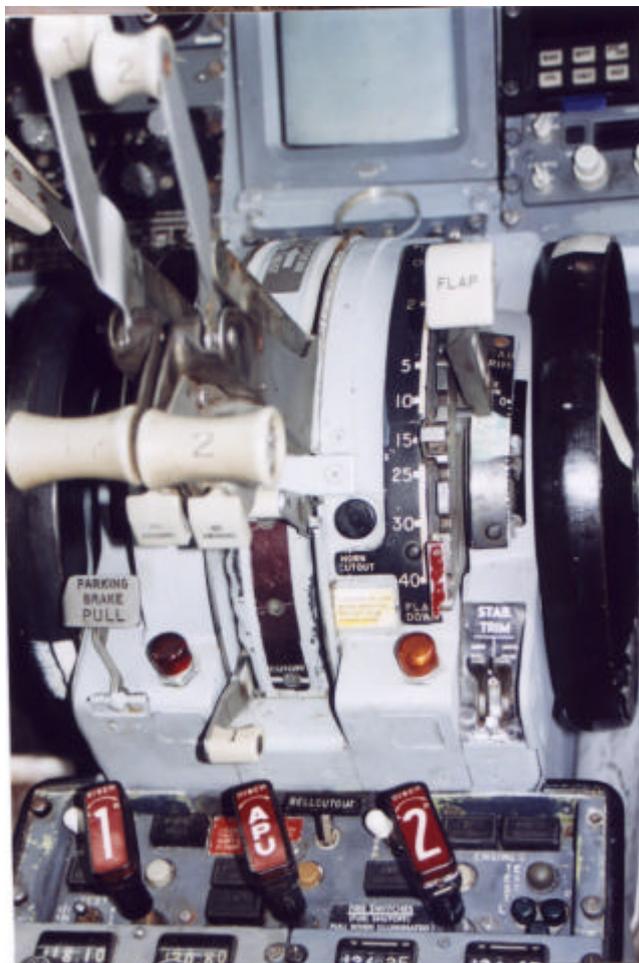
The rudder pedals were found to the full right, the steering at full left, and the power levers were found at full reverse. All the fire handles (engines and APU) were pulled and turned to the left. The flap selector was in detent 5, and the system is in good condition.

Pedestal, when NTSC investigation team arrived
