**FINAL**  
KNKT.08.10.18.04

**Aircraft Serious Incident Investigation**

**Alfa Flying School  
Cessna 172 ; PK-SDQ  
Cikampek KM 72 + 400 Highway  
Cikampek, West Java  
Republic of Indonesia  
29 October 2008**

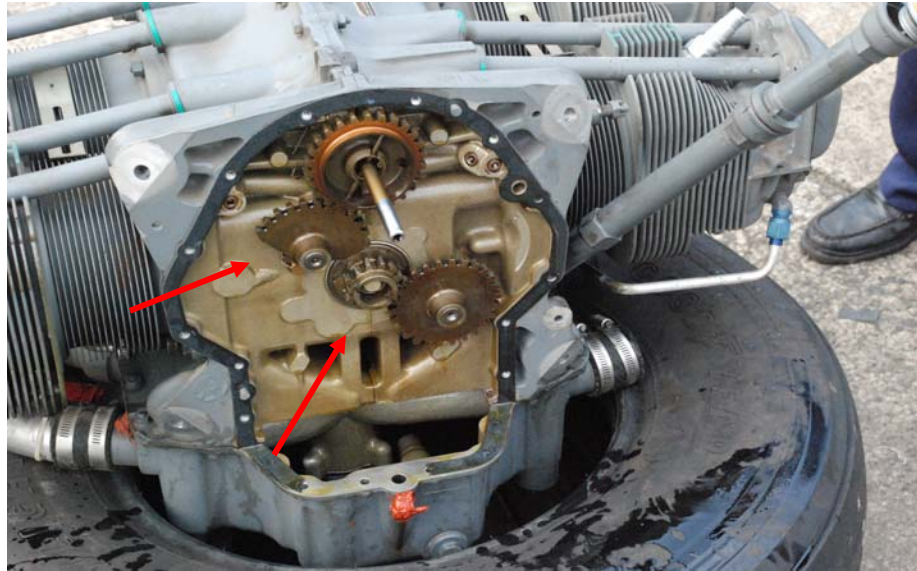
**Figure 1: Accessories Gear Case after being opened**

1. The Engine Rocker Box was opened and the propeller was rotated clockwise. It was found that rocker arm did not move. This indicated that the camshaft did not rotate.
2. The accessory gear case was opened. The investigation found that the crank shaft idle gear and the crankshaft gear were broken. Broken pieces of the crankshaft gear and the idle gear were sent to the Metallurgical Laboratory of the Institute of Technology, Bandung for further analysis.

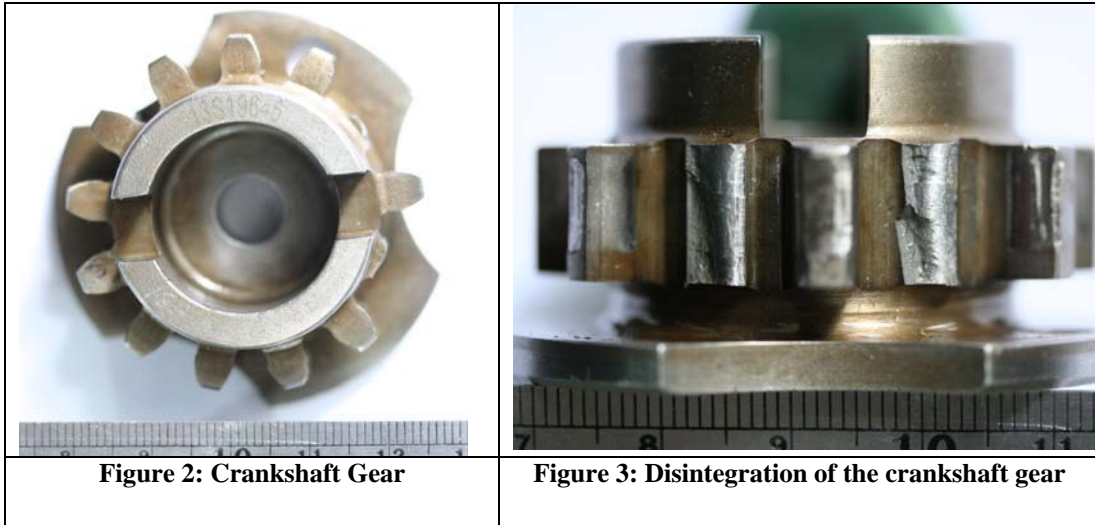
On the crankshaft gear there were two gear teeth that disintegrated/ detached (see figure 4). Other gear teeth of the crankshaft gear also indicated wear, pits or dent on the gear surface. The mode of failure on the detached gear teeth can be concluded as a fatigue failure (see figure 5). Fatigue fractures were propagated from the left side.

Gear surface finish was relatively rough.

Analysis on the failed crank-shaft gear showed that the wear, dent and pits on the contact surface indicated that the gear had a meshing / geometric problem. This indication was also supported by the fact that the surface finish was relatively rough, and machining marks were still visible on the matching gear surface. A gear grinding operation should be performed followed a hardening process. These showed that the gear failed due to improper manufacturing process.

The National Transportation Safety Committee recommends that Textron Inc. to review the manufacturing process performed to the failed crank-shaft gear and the possibility of similar condition to crank-shaft gear in the same manufacturing batch number.

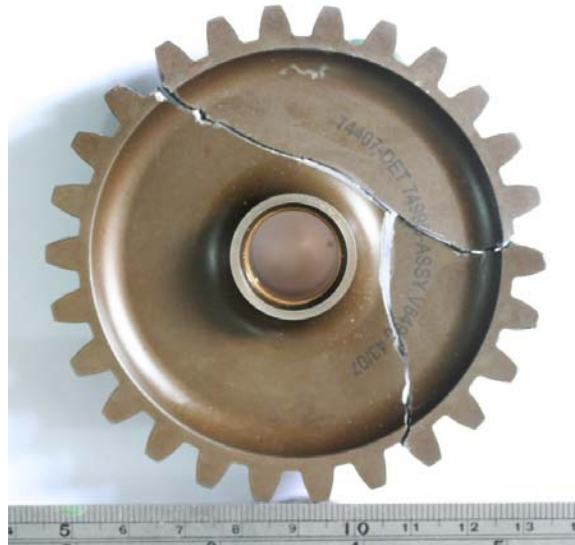
**Figure 4: Crankshaft idle gear**

The crank shaft idle gear failure was due to static overload. That is to say the failure of the crankshaft gear was followed by disintegration of the idle gear.

The failure of the crankshaft idle gear would then stopped the rotation of the magneto as well as the ignition, and followed by the engine quit.
