**KOMITE NASIONAL KESELAMATAN TRANSPORTASI
REPUBLIC OF INDONESIA**

Aircraft Serious Incident Investigation Report

Boeing 737-200; PK-JRW

Sentani Airport, Papua

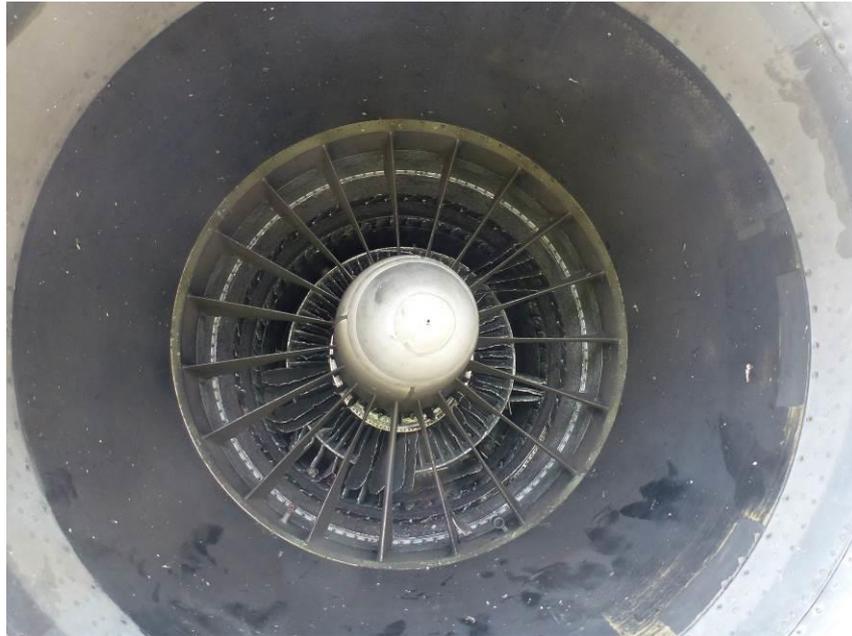
Figure 1: The right engine front view.

In general, no damage to the aircraft other than the right engine which was severely damage.

1. All blades of the engine compressor stage 1 until stage 5 were severely damage.
2. The blades of the compressor stage 6 were dent and bent.
3. The blades of the compressor stage 7 until stage 13 were bent, dent and (or) tear.
4. The combustion chamber and the High Pressure (HP) and Low Pressure (LP) turbine were no damages.

9. The borescope inspection result showed that the blade of the compressor stage 1 until stage 5 was severely damages. The blades of the compressor stage 6 were bend and dent. The blades of the compressor stage 7 until stage 13 were bend, dent and tear. The combustion chamber and all of the turbines were no damage.

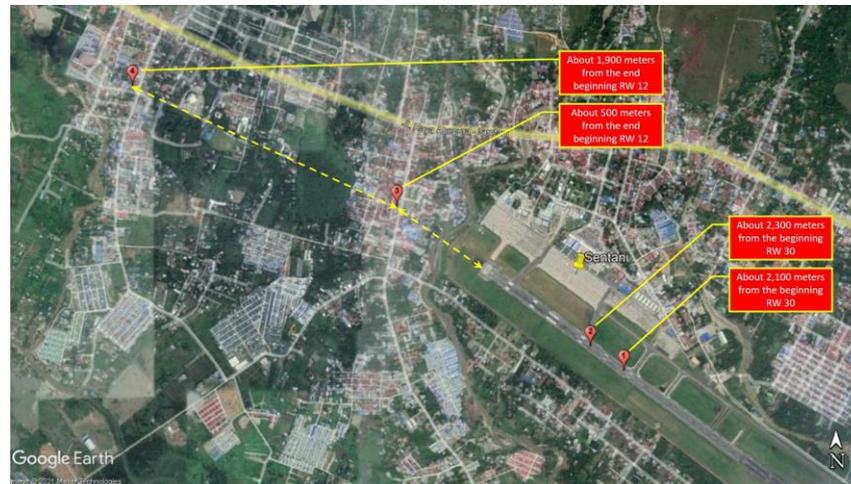
The debris of the fan blades of the right engine was found on the runway about 2,100 meters to 2,300 meters from the beginning runway 30.

The debris were also found on the residential place about 500 meters and 1,900 meters from the beginning of runway 12.

Figure 2: The estimated debris location of the right engine of PK-JRW
