**KOMITE NASIONAL KESELAMATAN TRANSPORTASI
REPUBLIC OF INDONESIA**

Aircraft Serious Incident Investigation Report

PT. Smart Cakrawala Aviation

Pilatus PC6/B2H4; PK-SNB

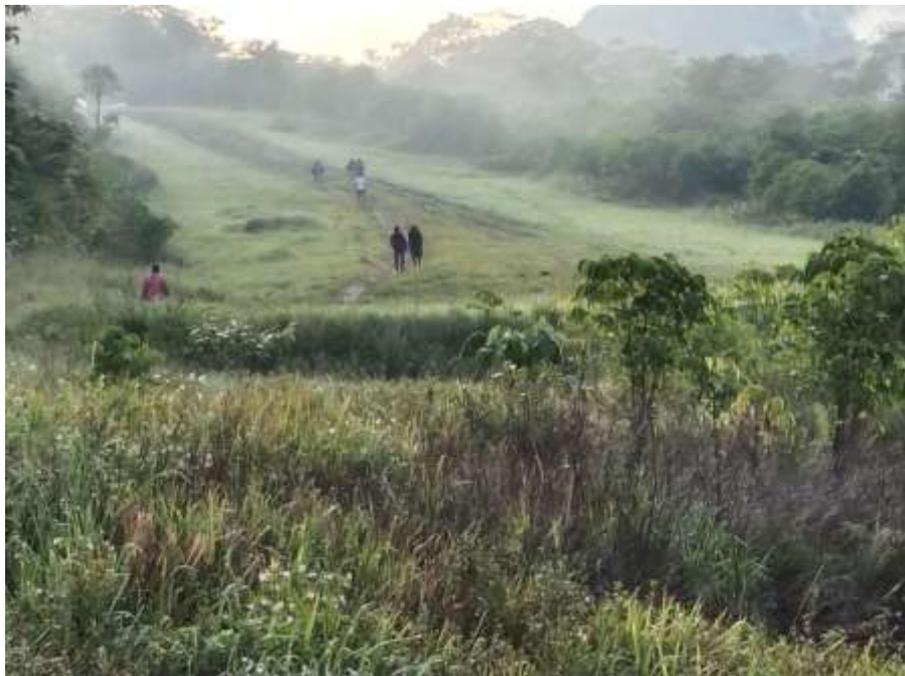
Figure 1: Runway condition of Bayabiru

The weather was reported clear, and the photo of the runway condition depicted some of runway surface was wet as there was rain at the night before. The pilot considered that was the typical condition of the runway at Bayabiru and decided to conduct the flight.

11. The weather at Bayabiru was reported clear, and the photo of the runway condition depicted some of runway surface was wet as there was rain at the night before. The pilot considered that was the typical condition of the runway at Bayabiru and decided to conduct the flight operation.

Therefore, the KNKT recommends the Smart Aviation to ensure flight operation to follow mitigation that have made by the company during hazard identification and risk assessment.

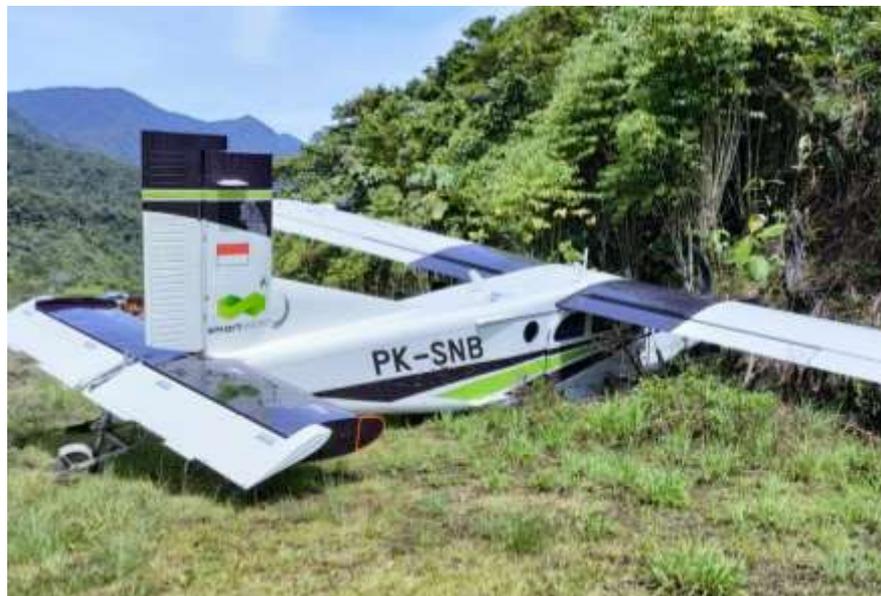
Figure 6: The aircraft condition taken after the aircraft stopped

After touched down, the aircraft veered and skidded to the left. Thereafter, the left wing impacted bushes on the left runway strip and the aircraft swung to the left then the right wing following by the aircraft nose impacted higher ground of the runway strip.

The aircraft stopped about 140 meters from touchdown on heading 345°. The aircraft tilted to the right as the right wheel was on a ditch with soft soil surface.

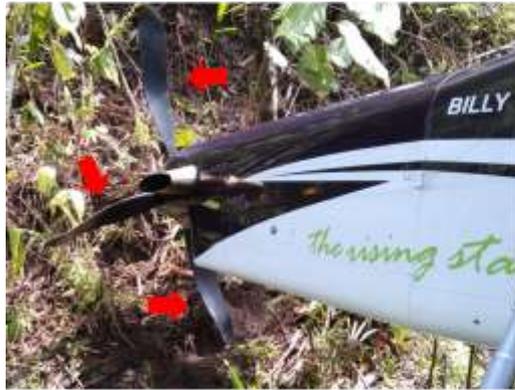
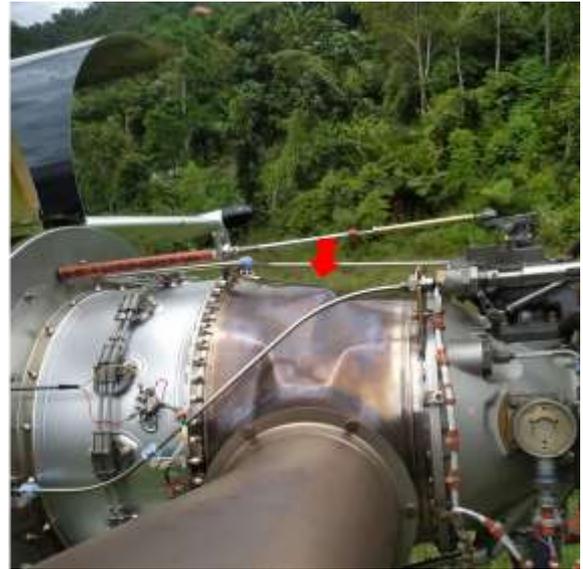
Figure 7: The damaged of the propeller blades (left figure) and wrinkled of engine power section (right figure)

- a. propeller blades damaged
- b. engine power section wrinkled

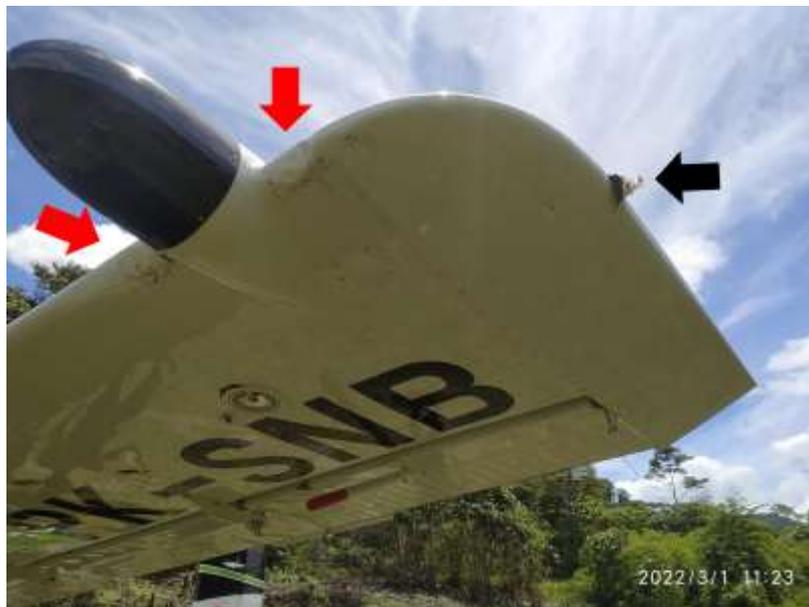
Figure 8: The bent of left-wing tip (red arrows) and the broken navigation light (black arrow)

- c. right wing tip damaged, and bent at wing rib station number 5610-6930
- d. left wing tip bent at wing rib station number 6600-6930
- e. both navigation lights broken
