**KOMITE NASIONAL KESELAMATAN TRANSPORTASI
REPUBLIC OF INDONESIA**

KNKT.16.11.40.04

Aircraft Serious Incident Investigation Report

Cessna 172P; PK-NIZ

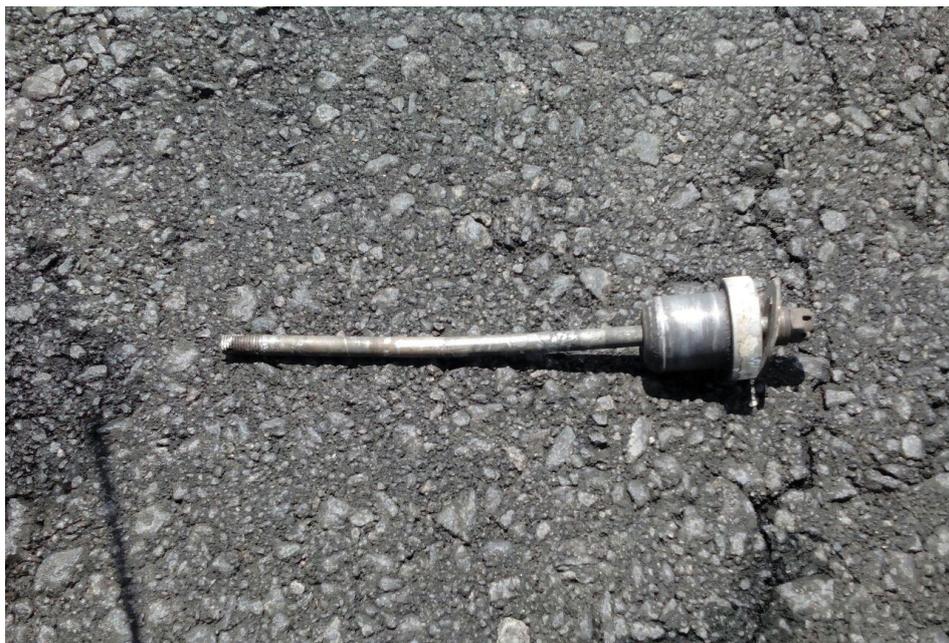
Metal scratch marks were found at touchdown area at approximately 8 meters length. The nose wheel axle through bolt was found on runway surface at approximately 500 meters from runway threshold and the nose wheel was found at runway shoulder at approximately 750 meters from runway threshold.

The nose wheel fork found scrap for about 5 centimeters and the propeller tip found bent forward for about 10 centimeters.

Figure 2: the nose wheel axle through bolt found on runway

To ensure the maintenance actions performed are recorded in the Maintenance Log Book.
