**PRELIMINARY**  
KNKT.13.12.34.04

**Aircraft Accident Investigation Report**

**PT. Derazona Air Service  
Bell 406 Helicopter; PK-DAL  
Berastagi, Sumatera Utara  
Republic of Indonesia  
30 December 2013**

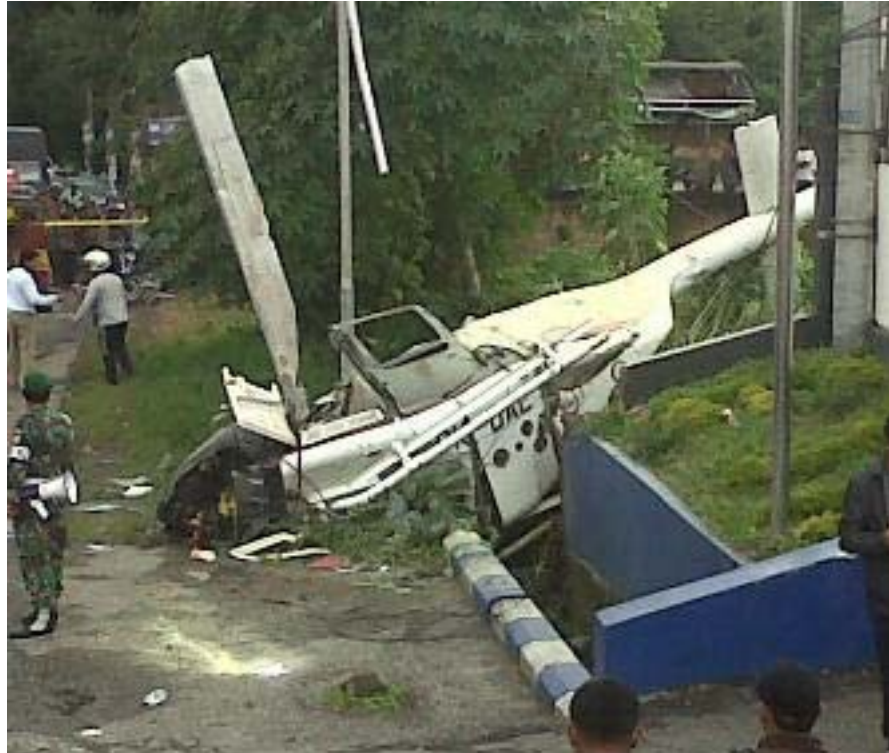
The helicopter was destroyed.

**Figure 2: Bell 206 registered PK-DAL after the accident**

The helicopter was destroyed by ground impact forces.

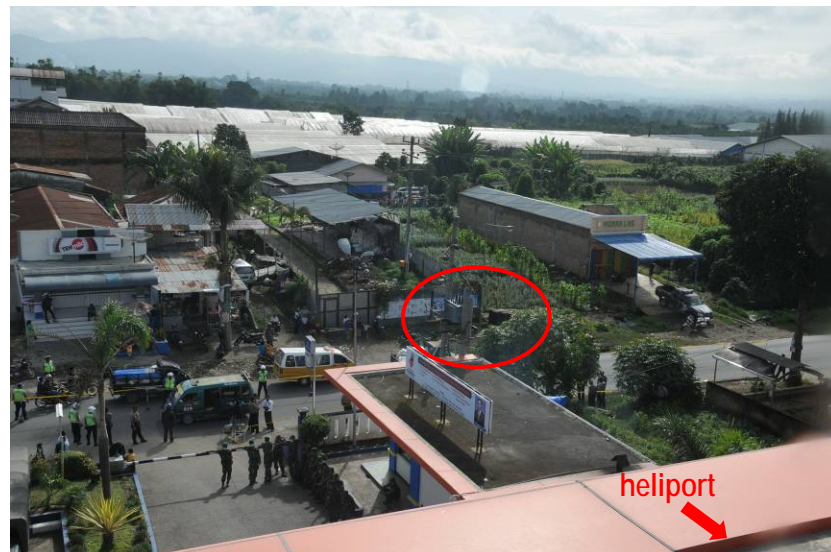
The helicopter was impacted with a 7 metres height electrical pole and fall to the road side-walk with 3 metres wide.

Most of the wreckage such as cockpit area, cabin area, main rotor blades, gear box and landing skid, were found at in one main wreckage. The tail boom and tail rotor was detached due to ground impact.

Figure 5: The accident site viewed from heliport

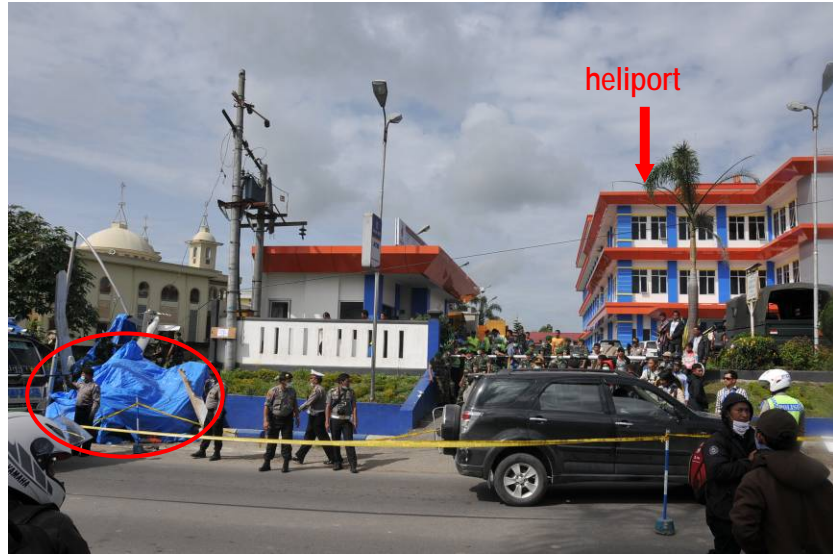
**Figure 6: The accident site and heliport**

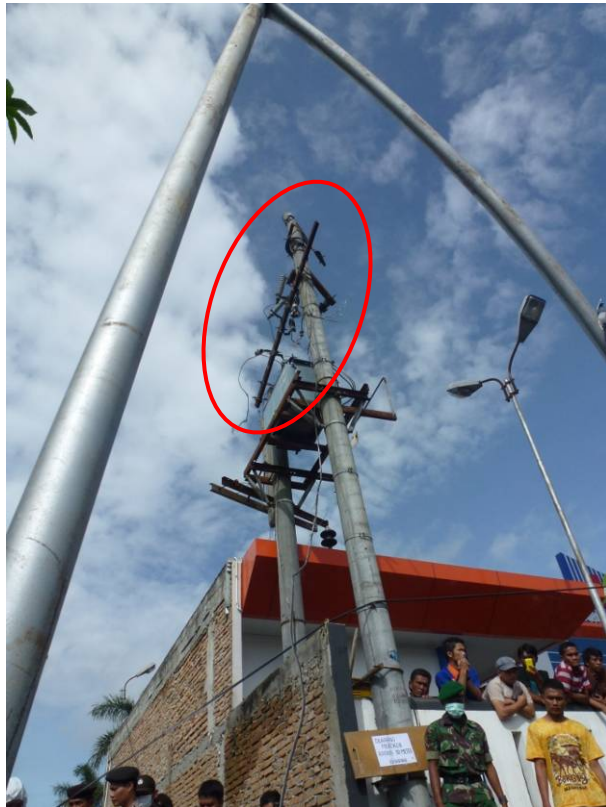
There was an electrical pole broken due to hit by the helicopter and the electrical was shut down for about 30 minutes in Kabanjahe District.

**Figure 7: The first impact with an electrical pole**

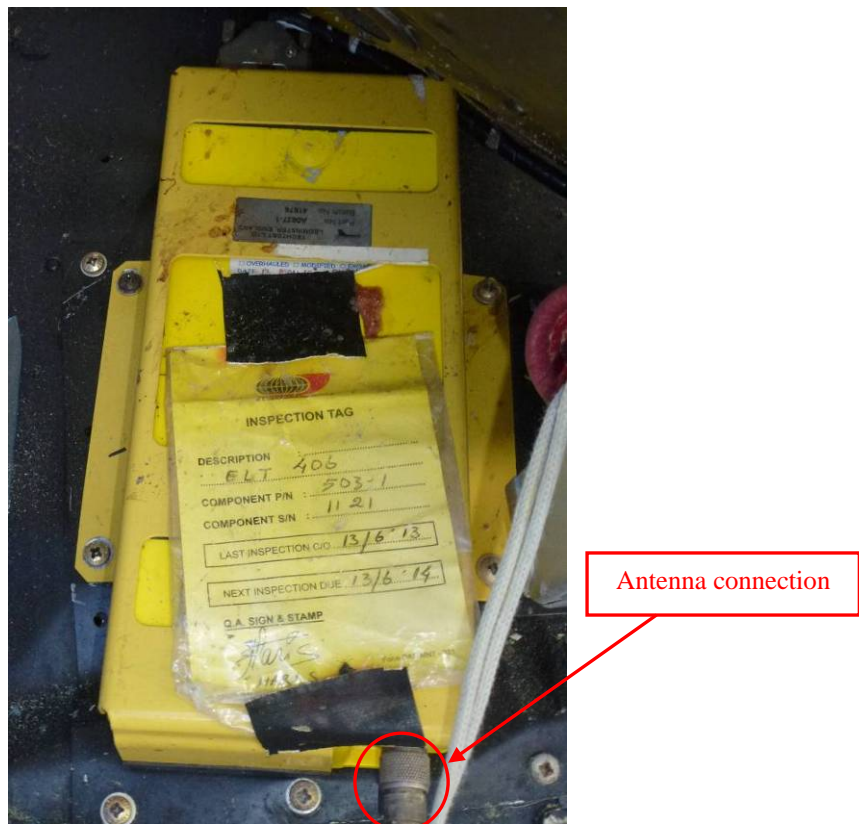
The ELT was found with antenna detached due to the high magnitude of impact/deceleration. The separation of the antenna from the ELT unit explained the reason of no distress signal was transmitted.

Figure 8: Emergency Locator Transmitter with antenna detached.
