PRELIMINARY
KNKT.15.03.08.04

Aircraft Accident Investigation Report

**PT. Hevilift Aviation Indonesia
Sikorsky S76 C+ Helicopter; PK-FUP
Delta Mahakam river, East Kalimantan
Republic of Indonesia
21 March 2015**

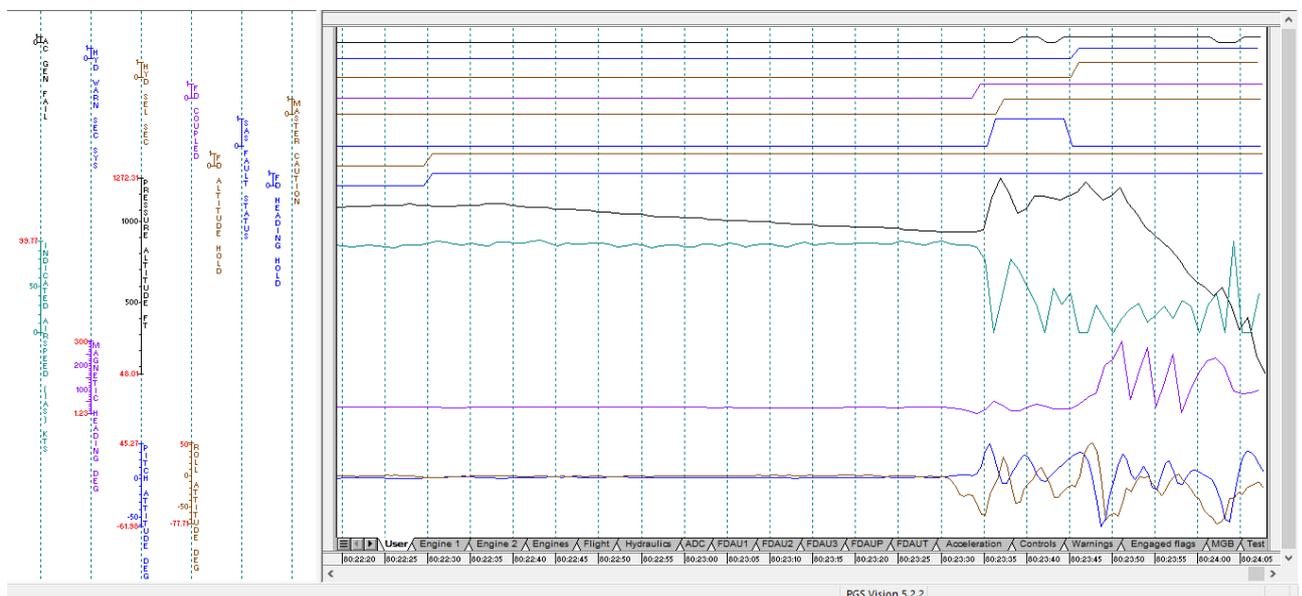
Figure 2. The Sequence of event recorded by flight recorder

When the aircraft 8 Nm from CPU the PIC ask the PF descend to 600 feet, the aircraft start descend 200 feet/minute. While the aircraft passing 800 feet suddenly the aircraft attitude changed un-commanded. The aircraft bank to the left, pitch up and nose down. The PF tried to lower collective pitch and reduce the aircraft speed. The PIC took over the control and tried to recover the aircraft until the aircraft impacted the tree and crash into a swamp.

When the aircraft passing 800 feet the aircraft attitude changed un-commanded, the aircraft bank to the left, pitch up and then nose down, the aircraft hit a tree and crash into a swamp. The aircraft was substantially damaged.

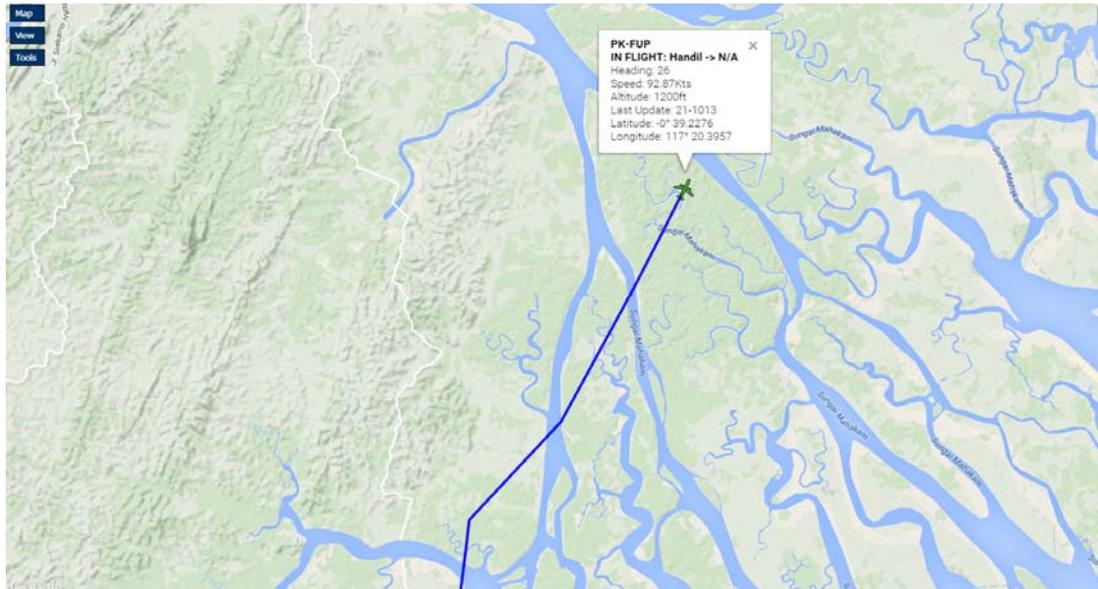
Figure 3. The aircraft PK-FUP accident route recorded in the Skynet.

The operator utilized flight following system by Skynet. This system was capable of monitoring the flight path as the data were transmitted by the aircraft periodically.
