PRELIMINARY
KNKT.15.03.08.04

Aircraft Accident Investigation Report

**PT. Hevilift Aviation Indonesia
Sikorsky S76 C+ Helicopter; PK-FUP
Delta Mahakam river, East Kalimantan
Republic of Indonesia
21 March 2015**

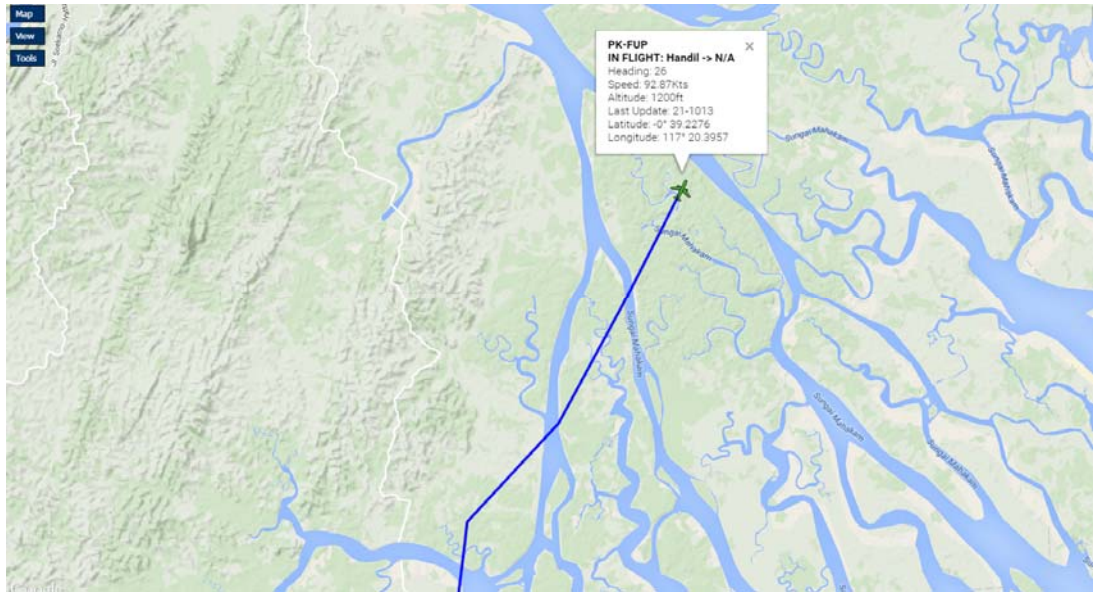
Figure 3. The aircraft PK-FUP accident route recorded in the Skynet.

The operator utilized flight following system by Skynet. This system was capable of monitoring the flight path as the data were transmitted by the aircraft periodically.
