**KNKT-12-09-03-03**

# **NATIONAL TRANSPORTATION SAFETY COMMITTEE**

**Investigation Into the Collision Between  
Indonesia Registered Ro-ro Passenger Ferry MV "*Bahuga Jaya*"  
and Singapore Registered MT "*Norgas Cathinka*"  
at Sunda Strait (4 Nautical miles east of Rimau Balak Island),  
Indonesia**

**26 September 2012**

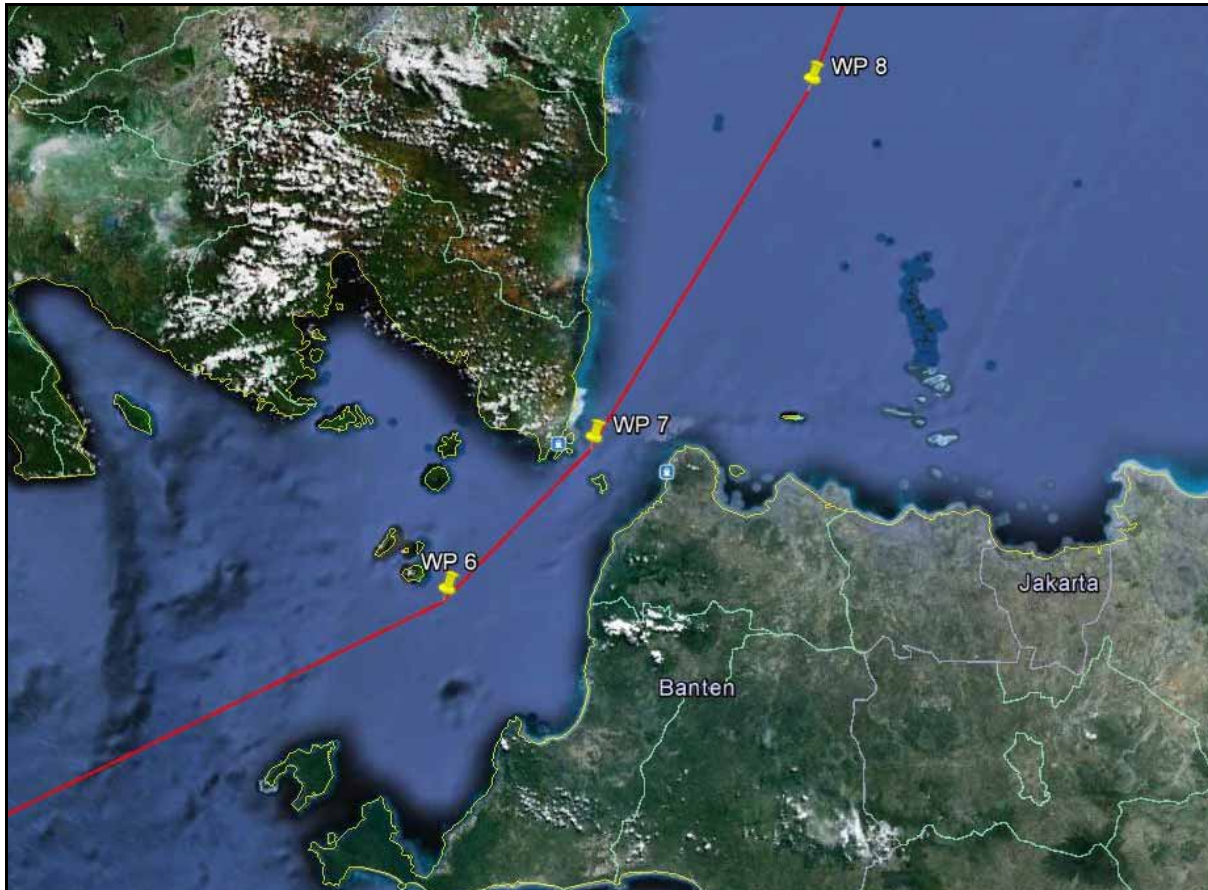
**Figure-3: Norgas Cathinka Passage plan transiting Sunda strait<sup>8</sup>**

The passage plan's information for travelling through Sunda strait includes heavy crossing traffic and the need to maintain a standing watch 1 or 2 (watch level<sup>9</sup>) at the discretion of the master. On this voyage through the Sunda strait, the Master decided to maintain standing watch level 2.

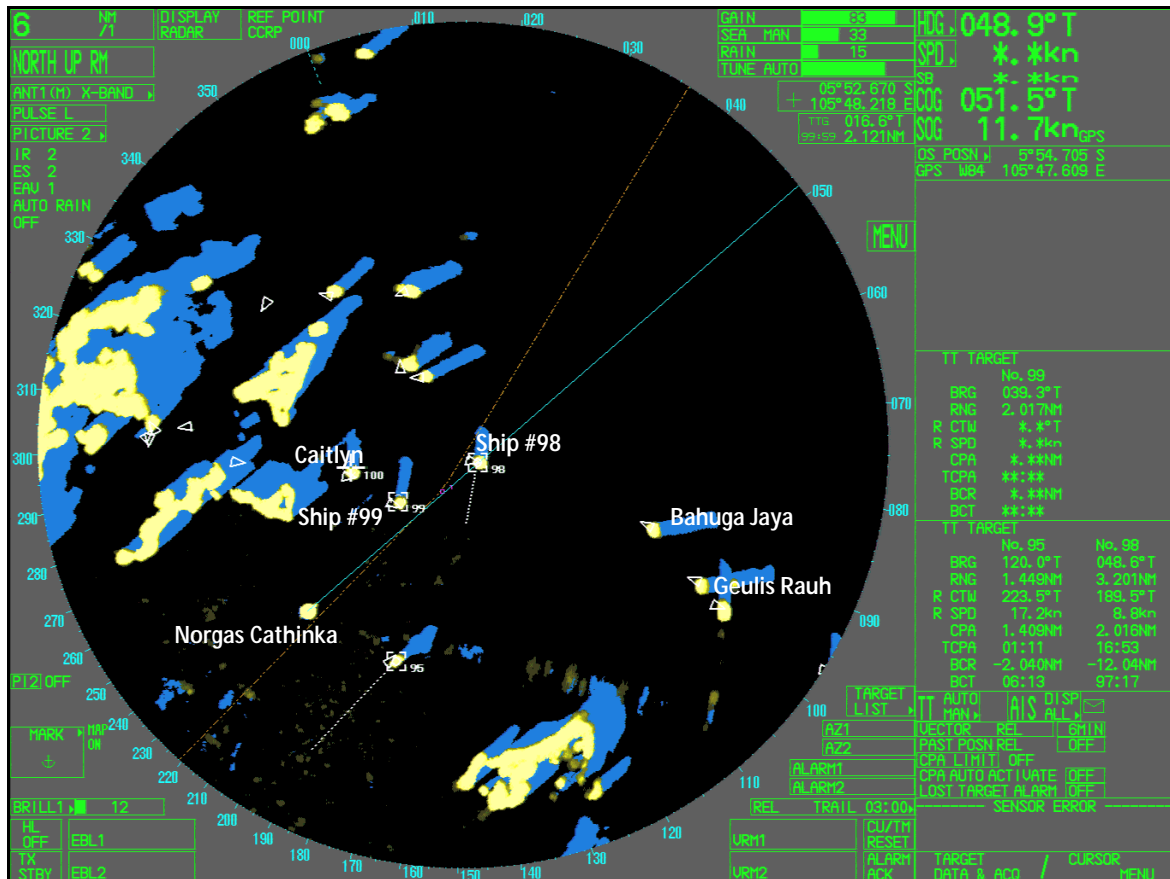
At 0426, one of the eastbound targets (ARPA target 98 in Figure-6) crossed Norgas Cathinka's bow more than 3 Nm off. The other eastbound targets were also acquired (targets 99 and the ferry Caitlyn).

Figure-6: Norgas Cathinka's radar captured image at 0426

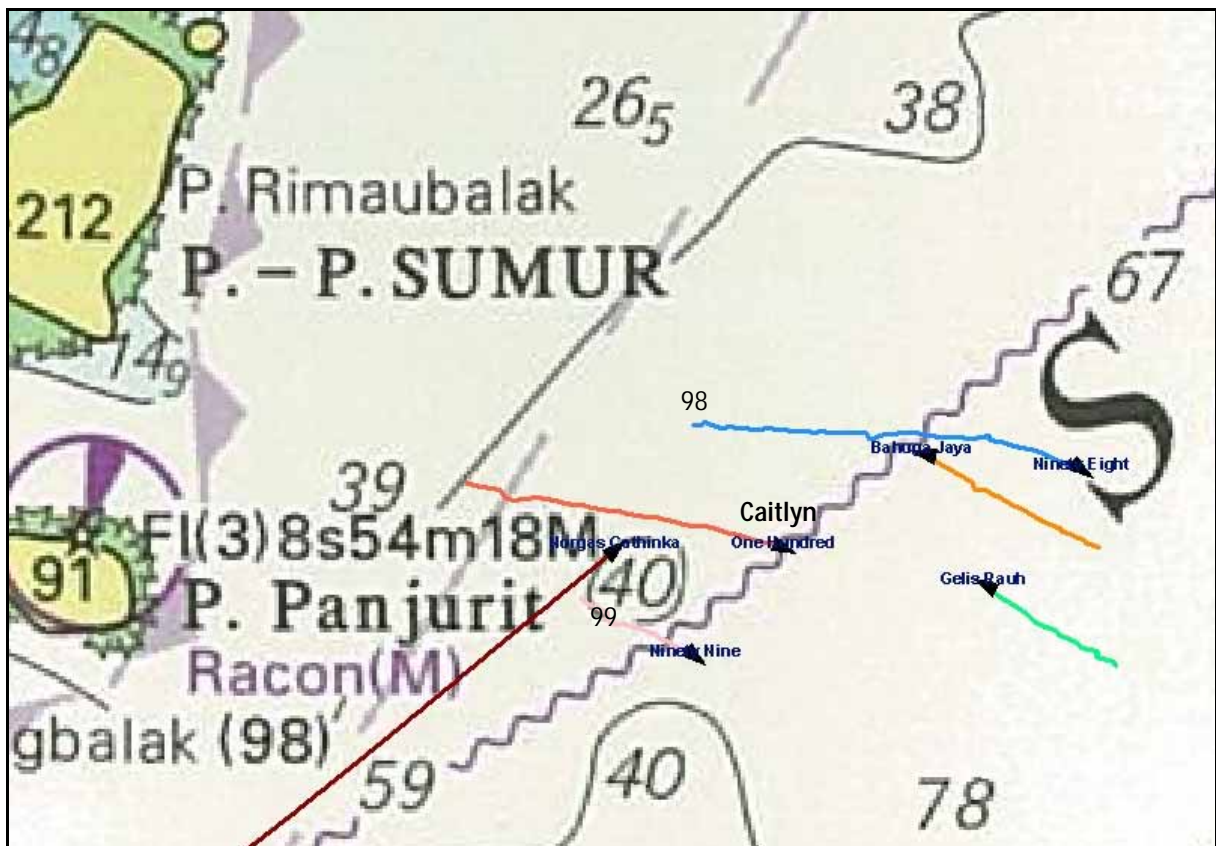
At 0436, the last of the eastbound targets, ferry *Caitlyn* crossed *Norgas Cathinka's* bow at a distance of about 1 Nm. Target 99 was nearly abeam to starboard and passing clear while target 98 was well clear. *Bahuga Jaya* was still on a collision course on a bearing of about 074 (T).

*Figure-7: All vessels position at 0439*

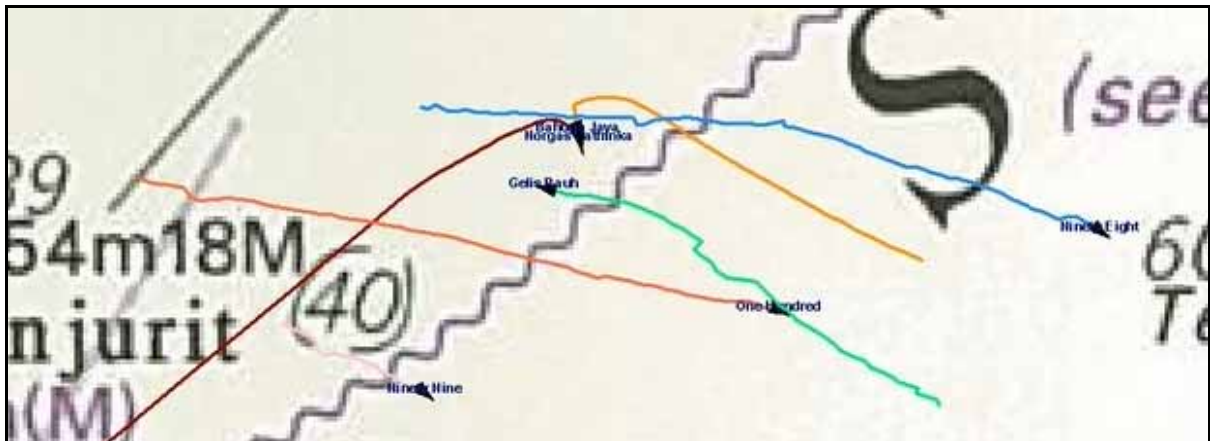
**Figure 8: All vessels position at 0444 ¼**

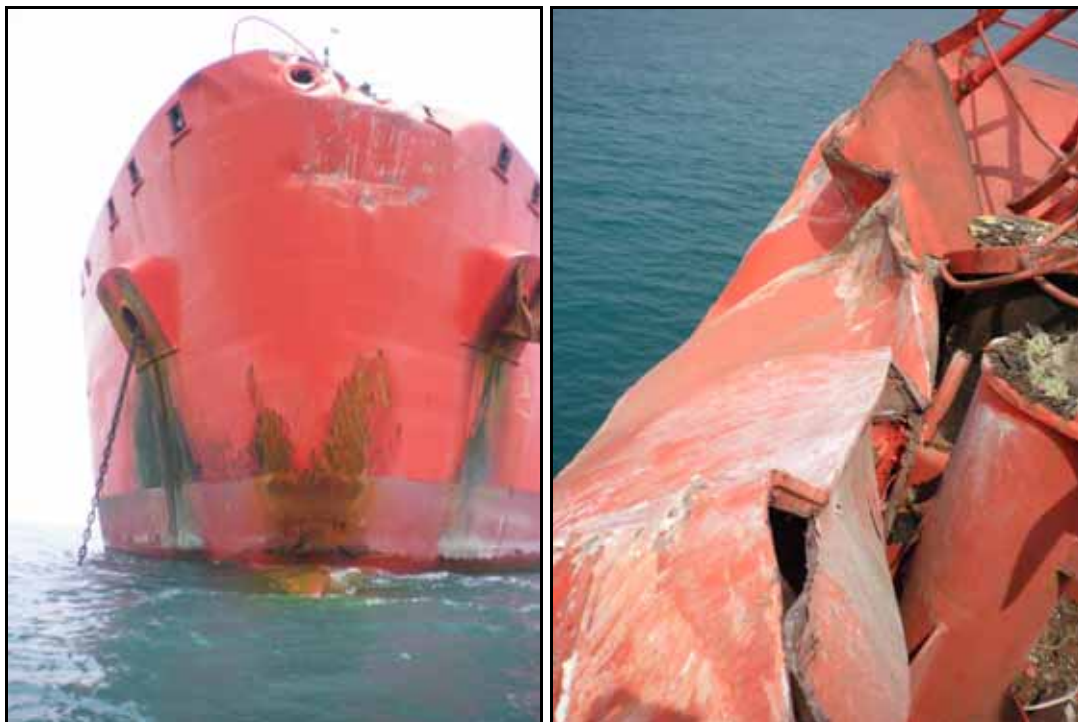
- Port bulwark top section bulwark plate and its stanchion were buckled inward;
- The 250 kg SWL manual crane next to the forecastle hatch was collapsed;
- Port foremost fair ladder and its bracket connection to the deck found buckled;
- Starboard bulwark top plate at in way of fair ladder buckled inward;
- An open crack of 300 mm long sighted;
- Shallow indentations found on forward stem plating in way of breasthook area, 1 frame found distorted.

*Figurel-9: Collision mark at the bow and ruptured port forecastle's bulwark*

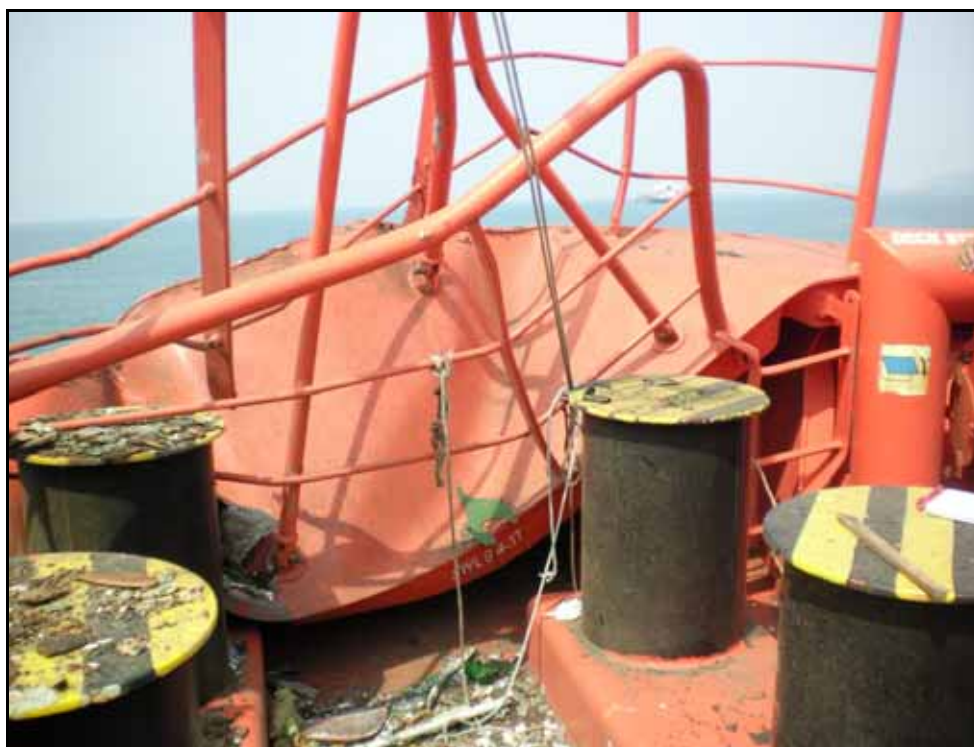
*Figurel-10: Bukled forecastle structure of the Norgas Cathinka*

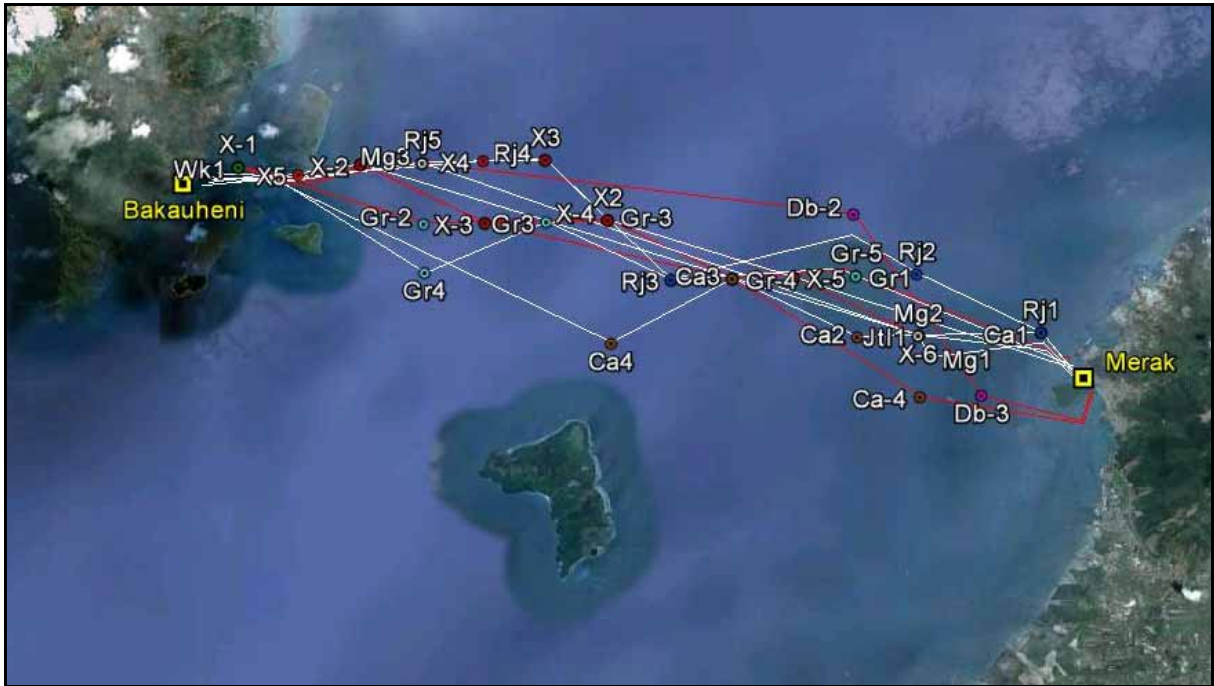
**Figure II-1: Merak – Bakauheni ferry manoeuvring pattern based on NTSC survey (red line: ferry to Merak, White Line: ferry to Bakauheni)**

There was also no specific line for the ferry to transit the route. The figure above shows the typical manoeuvring pattern of Merak – Bakauheni ferries. The manoeuvring line was generated based on the vessel's position recorded during the survey. The pattern indicates that the ferries moved irregularly for both destination of Merak and Bakauheni. During interview to the Ferry's Officer, the manoeuvring pattern was influenced by state of the strait current, action to avoid collision with the other vessel/s and daily normal ferry deck officer's seamanship.

The conditions of irregular manoeuvre might made confusion for other vessel that crossing the Sunda strait. To maintain a safe passage in the area and to avoid similar dangerous 'near-missed' accident there should be a traffic separation scheme within both destinations Merak and Bakauheni. It is intended that in the cruise ferries routes could be clearly specified so that particularly looks safety and in order.

- To recommend ferry route between Merak – Bakauheni i.e. separating the eastbound lane to the westbound lane by a buffer zone.
