Aircraft Serious Incident Investigation Report

Cessna 172S; PK-BOB

Blimbingsari Airport, Banyuwangi, East Java

28 January 2014

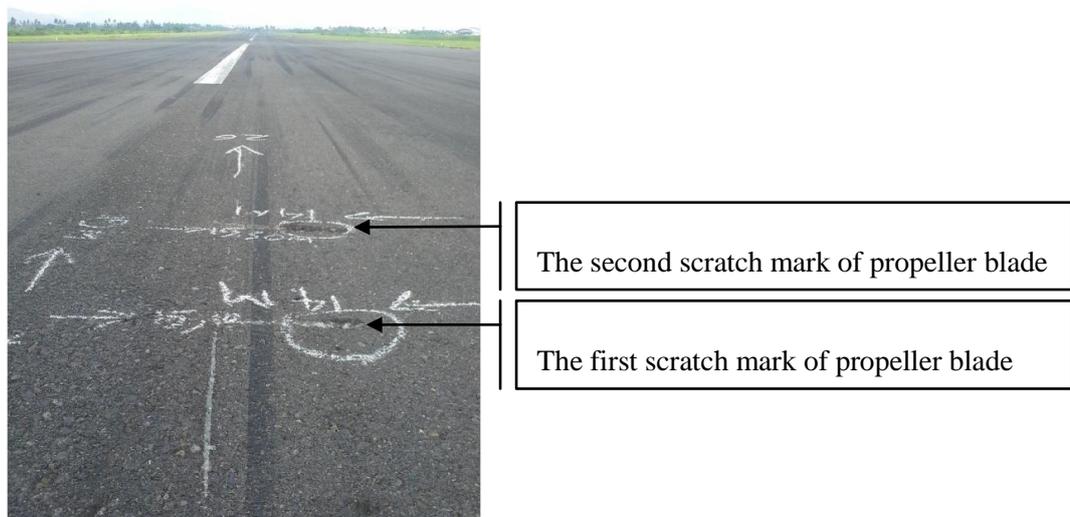
Propeller scratch marks were found on the runway at approximate 200 feet from the beginning runway 08 near the runway center line.

Figure 1: Two propeller scratch marks found on runway 08

Observation on the damage of propeller blades and the nose tire found that the blades bent for more than 40° and the nose tire ripped. It indicated that on touchdown the propellers and the nose tire hit the runway surface. It was consistent with the two propeller scratch marks found at approximately 200 feet of the beginning runway 08.

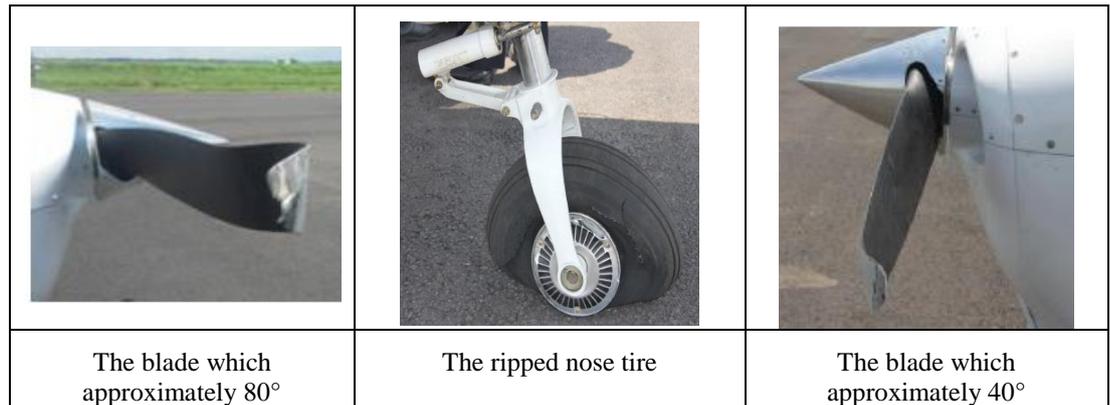
No one injured in this serious incident. Examination of the aircraft found propeller blades tip bent and the nose wheel tire ripped.

Figure 2: The aircraft damage observed after aircraft parked

5. Two propeller scratch marks were found at approximate 200 feet from the beginning runway 08. Observation on the aircraft found the nose wheel tire ripped and both propeller blades tip bent. Indicated that the aircraft had steep nose down attitude during landing.

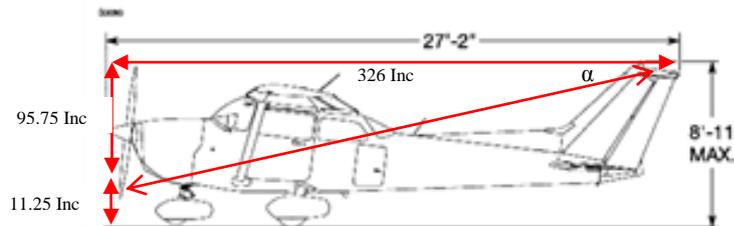
Refer to the aircraft dimension and application of simple formula $\tan \alpha^\circ = 95.75 \text{ Inc}$ divided by 326 Inc resulted 16° , and this means that the propeller tips might contact to the ground at an angle approximately 16° pitch down.

The steep angle approach of approximately 16° and resulted to the propeller contacted the runway surface.
