**NATIONAL TRANSPORTATION SAFETY COMMITTEE
REPUBLIC OF INDONESIA**

FINAL
KNKT.15.12.10.03

Marine Safety Investigation Report
Collision between
Antigua and Barbuda Registered
General Cargo *THORCO CLOUD*
and Cayman Islands Registered
Tanker *STOLT COMMITMENT*
Singapore Strait 16 December 2015

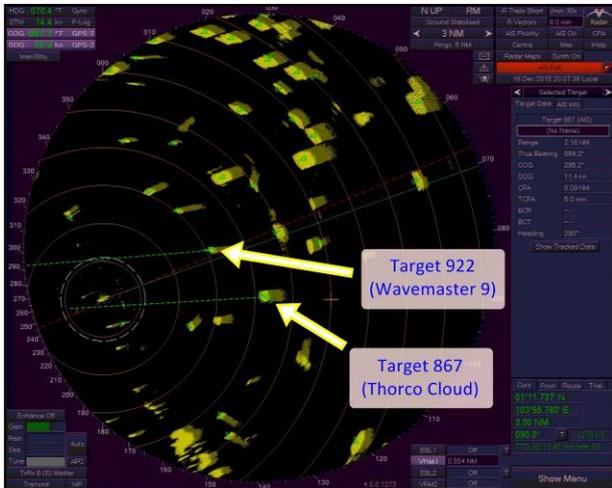
Figure 3: Wavemaster 9 & Thorco Cloud on Stolt Commitment's radar

At around 20.10 LT, the OOW was checking a target on the radar named Target 867 as shown in Figure 3. Initially, the radar system showed no name for the target 867. But thereafter, the radar system showed it as the *Thorco Cloud* when the range was 0.92 NM.

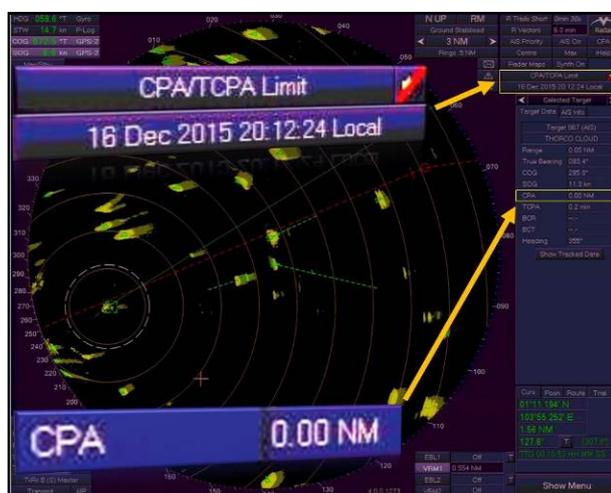
At around 20.12 LT, the Master of *Stolt Commitment* asked the OOW to check the CPA of *Thorco Cloud*. The OOW then informed the Master that the closest point approach (CPA) of *Thorco Cloud* was zero (0) nautical mile as shown in Figure 4. At that time, the distance between both

Figure 4: The CPA between Stolt Commitment and Thorco Cloud was zero

vessels was 0.8 NM. However, the Captain of *Stolt Commitment* did not order the crew to alter the course or reduce the speed.

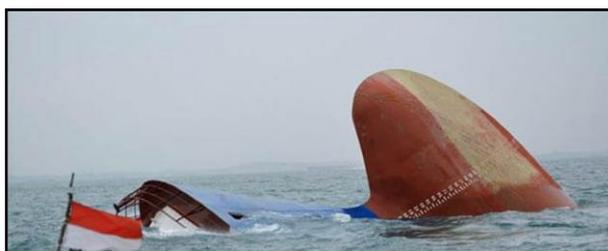
At around 20.13 LT, the collision between *Thorco Cloud* and *Stolt Commitment* occurred at 1°12.2' N and 103°54.1' E or around 5 NM from Batam Port in Indonesian waters. The bulbous bow of *Stolt Commitment* collided the port side of *Thorco Cloud* between midship and accommodation room. As the result, the *Thorco Cloud* was broken into two parts, specifically fore and aft parts.

Figure 5: The bulbous bow of Thorco Cloud

Around 9 minutes after the collision, the AIS signal from *Thorco Cloud* disappeared. The aft part sank first, while the fore part was floating in which the bulbous bow was facing upward.

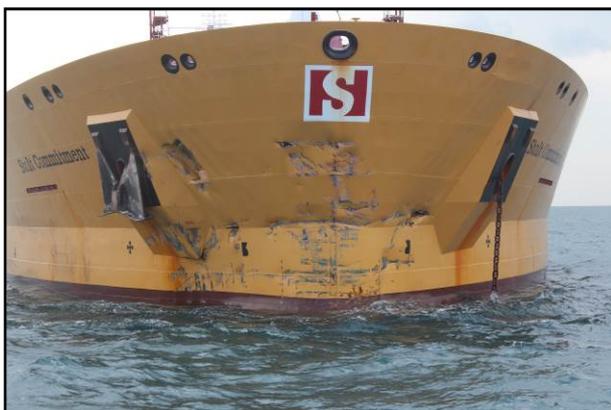
Figure 6: Minor damage on Stolt Commitment due to the collision

On the other hand, *Stolt Commitment* suffered minor damage on her bulbous bow and the haws pipe of starboard side as seen in Figure 6. She was in a stable condition because the damage did not allow water to ingress into the spaces forward of the collision bulkhead. After the joint investigation (the MPA Singapore and the NTSC Indonesia) had been done, the ship continued the voyage to Singapore to be checked by the marine surveyor.

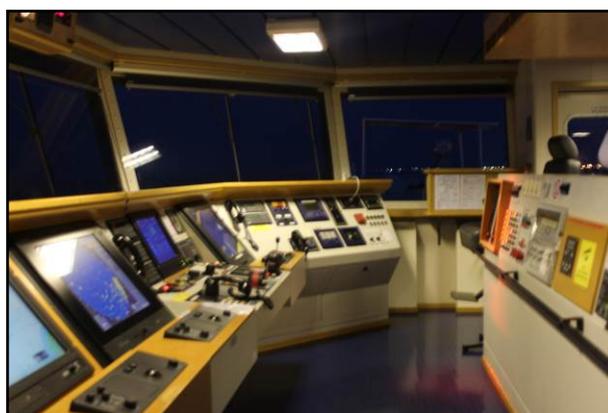
Both the Master and the OOW of *Stolt Commitment* acknowledged that their ship supposed to give way to the *Thorco Cloud*. However, as the *Stolt Commitment* was on the TSS, the Master of *Stolt Commitment* thought that the *Stolt Commitment* has the priority over the *Thorco Cloud* which was off the TSS. Furthermore, in reference to the interview, this point of view developed an

Figure 10: The situation on the bridge of *Stolt Commitment* towards the starboard side

assumption that the *Thorco Cloud* will give way to the *Stolt Commitment*, even though the *Thorco Cloud* was on their starboard side.

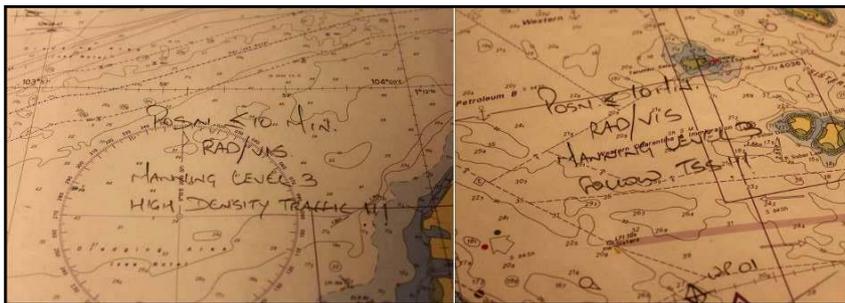
Figure 11: The note given on the chart of *Stolt Commitment*

Before the voyage, they planned to pass the Singapore Strait with the manning level set to level 3. There were a couple of notes regarding the high-density traffic in the Singapore Strait to anticipate any consequences derived by the considerable number of vessels crossing the channel as in Figure 11. However, the notes were not effective as she was sailing nearly at her top speed. With the speed as in an open sea, it is more difficult for the ship to take any action in avoiding the collision.

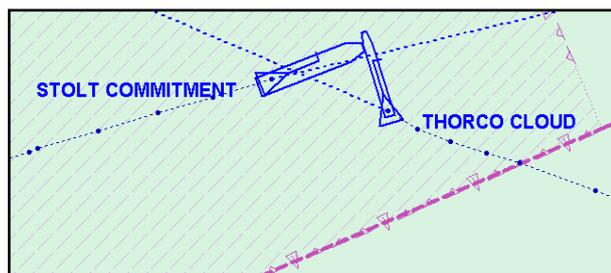
Figure 12: Both vessels whilst the collision (source: Batam VTS)

vessel (*Thorco Cloud*) finds that the give way vessel (*Stolt Commitment*) cannot take an action alone, the stand on vessel should take an action to avoid collision in an adequate time by considering her speed and the distance to the surrounding situation. Despite the *Stolt Commitment* altering to the port side which was correct to reduce the collision impact, the action was taken in the latest time which gave both vessels no time to avoid the collision as depicted on Figure 12.
