**KOMITE NASIONAL KESELAMATAN TRANSPORTASI  
REPUBLIC OF INDONESIA**

**Aircraft Serious Incident Investigation Report**

**PT. Lion Mentari Airlines**

**Airbus A330; PK-LEF and Boeing 737-800; PK-LJR**

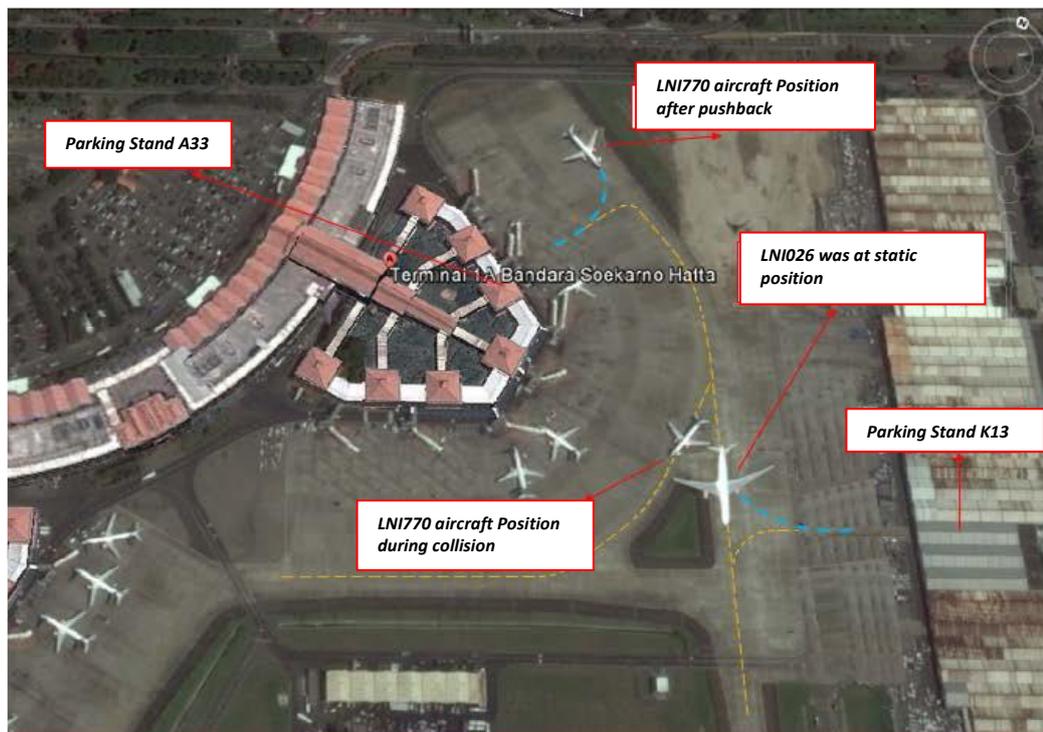
**Figure 1: illustration of the aircraft movement (not to scale)**

At 1159 UTC, the ground controller advised the LNI770 pilot to stop the taxi. The LNI770 aircraft position was on taxiway SCX. The LNI770 pilot requested to return to the gate to inspect the left wing condition.

Both aircraft returned to the parking stands and cancelled the flights. No one injured as result of this occurrences.

Both aircraft had minor damage. The tip of left winglet of LNI770 was cut off. The lower right wing LNI026 dent and scratch at approximately two meters from the wingtip.
