**FINAL**  
KNKT.08.10.18.04

**Aircraft Serious Incident Investigation**

**Alfa Flying School  
Cessna 172 ; PK-SDQ  
Cikampek KM 72 + 400 Highway  
Cikampek, West Java  
Republic of Indonesia  
29 October 2008**

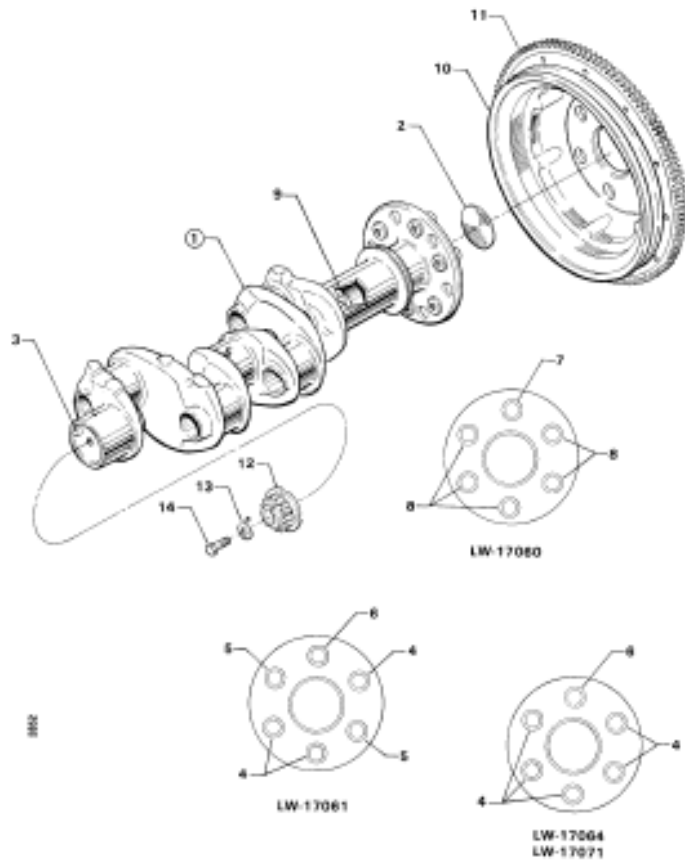
Figure 6: Refer to Avco lycoming part catalogue, Crankcase, Crankshaft and Camshaft Group

The failure of the crank-shaft gear was due to contact/meshing problem. There were evidence of wear, pits and dents on its gear surface. The gear surfaces were relatively rough; the machining marks were still on the gear surfaces. It indicated that the final dimension of the crank-shaft gear was improper causing extraneous load. A gear grinding operation should be performed following a hardening process. These showed that the gear failed due to an improper manufacturing process.

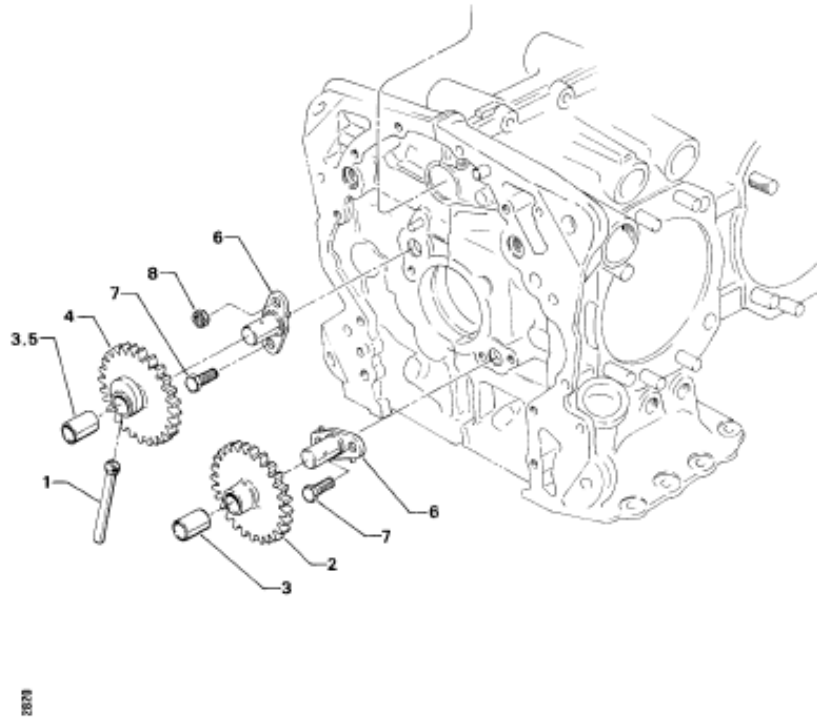
Figure 7: Refer to Avco Lycoming part catalogue, Cranksaft Idler Gear

The crank shaft idle gear failure was due to static overload. That is to say the failure of the crankshaft gear was followed by disintegration of the idle gear.

The failure of the crankshaft idle gear would then stopped the rotation of the magneto as well as the ignition, and followed by the engine quit.
