**KOMITE NASIONAL KESELAMATAN TRANSPORTASI
REPUBLIC OF INDONESIA**

Aircraft Serious Incident Investigation Report

PT. Smart Cakrawala Aviation

Pilatus PC6/B2H4; PK-SNB

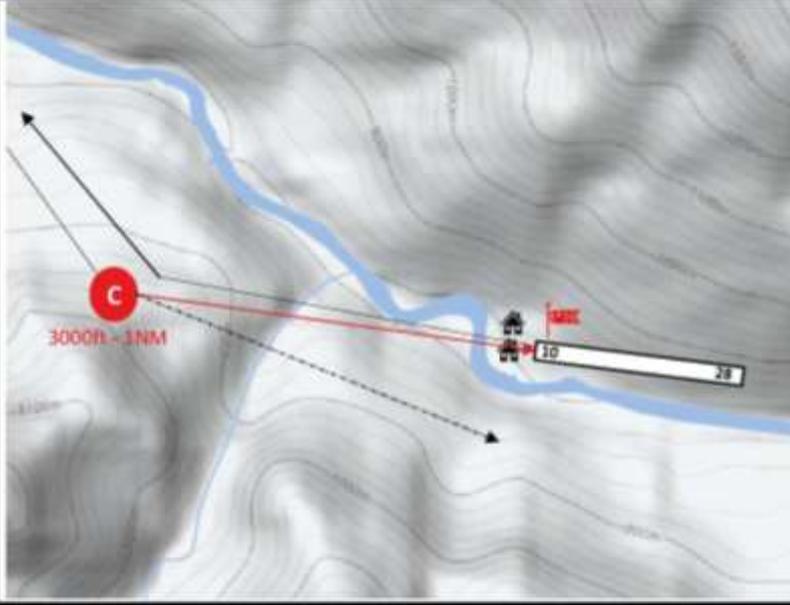
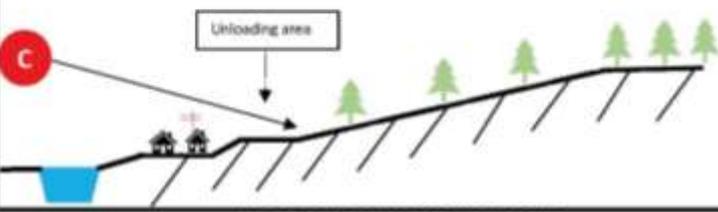
BAYA BIRU - BYB	R105 NBR 47NM (30')
	S03 37.09 E136 15.94	WIND TIME 10:30

Frequency	122.1 / 122.4
	Length	350m / 25m
	TDZ Elev.	2500 ft
	TOP Elev.	2550 ft
	Slope	5% to 7% UP
	Surface	Grass
	MLW	TBD
	Vref	60kts

ROUTING	
	WABI	S 03° 22.00'E 135° 30.00'
	PTB	S 03° 30.39'E 135° 54.59'
HAZARDS / OBSTACLES / REMARKS		BYB S03° 37.09' E136° 15.94'
Situated in a tight valley, terrain to the South and North Small antenna on short final on top of the roof. Often helicopter traffic Occasional morning fog and rain by mid day Wind picks up from around 9 to 10 AM (often westerly wind for landing. (tailwind) Tariku PAC750 airframe parked at end of runway turn around area Grass tends to grow fast. If too tall ask them to cut the grass Unloading and loading at bottom of the strip		ALTITUDE VMC
LANDING		WABI - BYB: 7500ft BYB - WABI 6500ft
Landing runway 10 only / go around follow the river/ Unable to stop swerve right

TAKEOFF		
Takeoff runway 28 only / aborted takeoff swerve to the right if unable to stop / Engine failure: go for the river

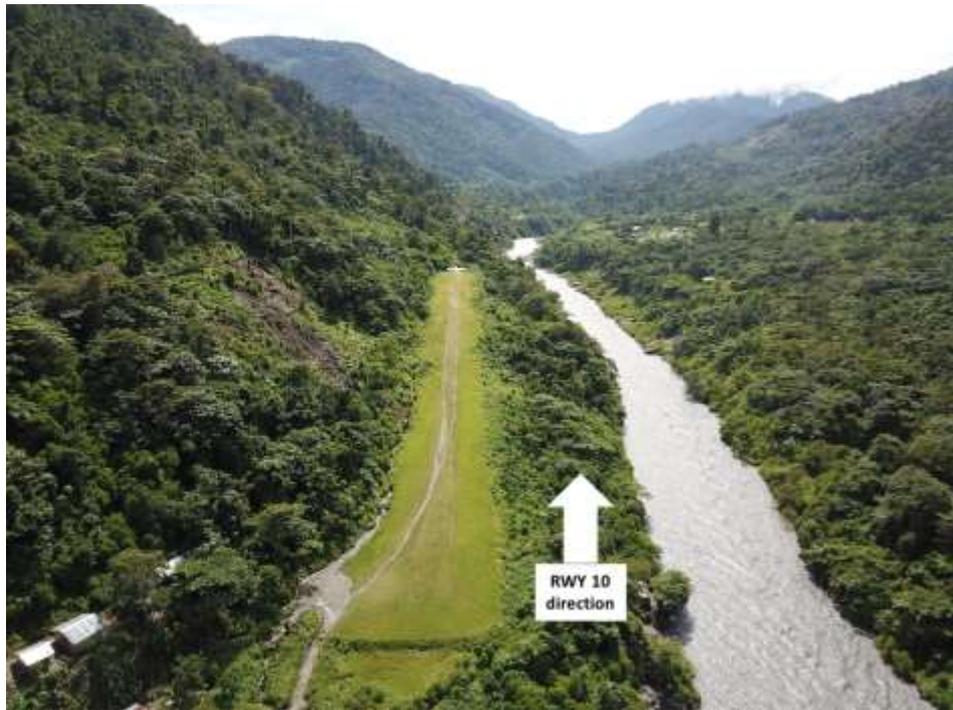
Figure 3: The airstrip condition (taken in 2020)

The Smart Aviation used the runway 10 for landing and runway 28 for takeoff.

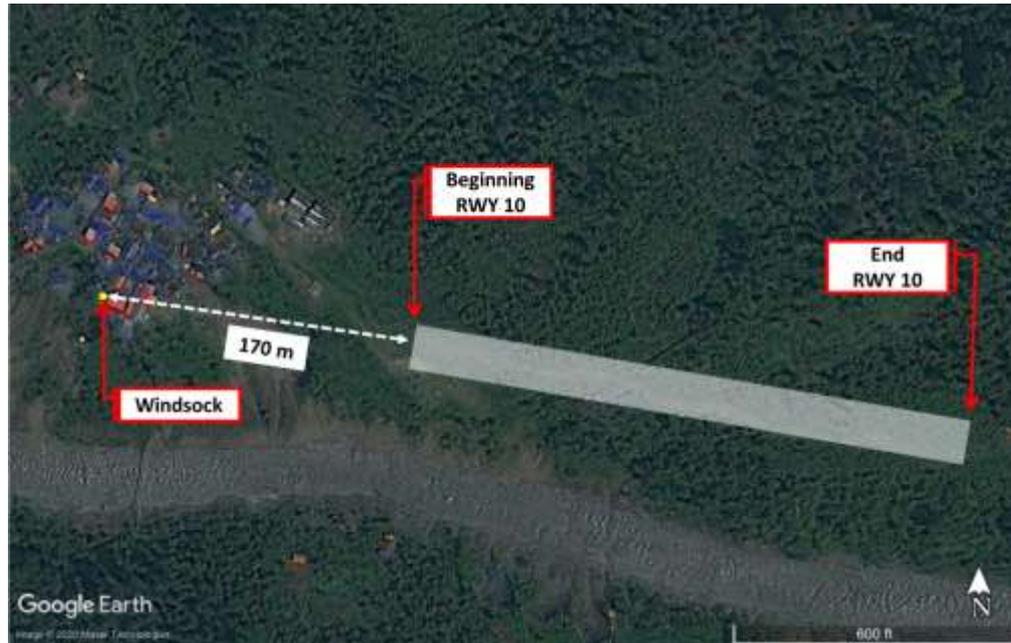
Figure 4: The windsock location (yellow dot) and the airstrip

The airstrip was equipped with wind shock, located on the settlements near the airstrip about 170 meters from beginning runway 10 on bearing 275°.
