**PRELIMINARY**  
KNKT.13.12.34.04

**Aircraft Accident Investigation Report**

**PT. Derazona Air Service  
Bell 406 Helicopter; PK-DAL  
Berastagi, Sumatera Utara  
Republic of Indonesia  
30 December 2013**

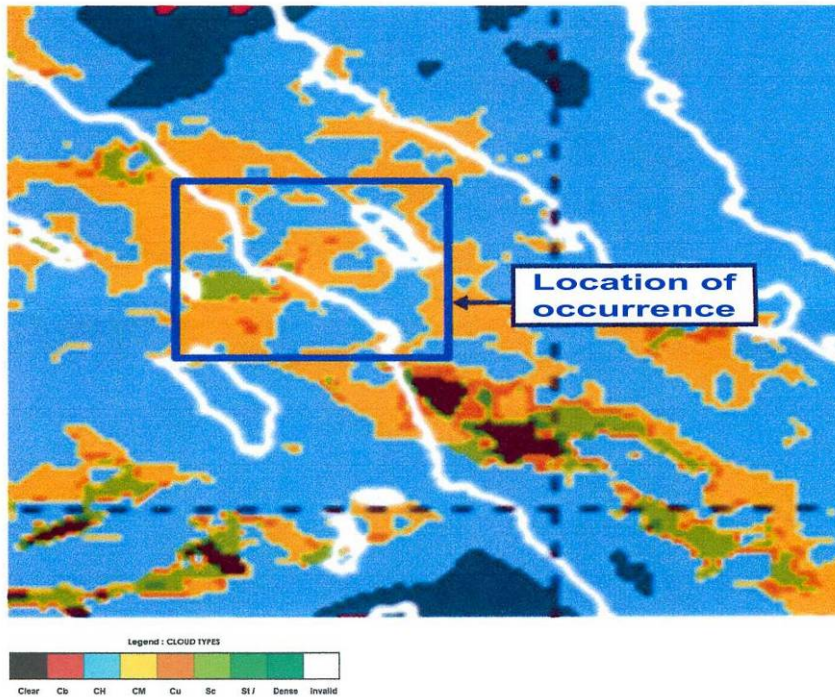
**Figure 3: Satellite image at 0300 UTC**

Refer to Satellite image (figure 2 and figure 3) shown that at the time of occurrence, the area weather was Cumulus could.
