PRELIMINARY
KNKT.15.03.08.04

Aircraft Accident Investigation Report

**PT. Hevilift Aviation Indonesia
Sikorsky S76 C+ Helicopter; PK-FUP
Delta Mahakam river, East Kalimantan
Republic of Indonesia
21 March 2015**

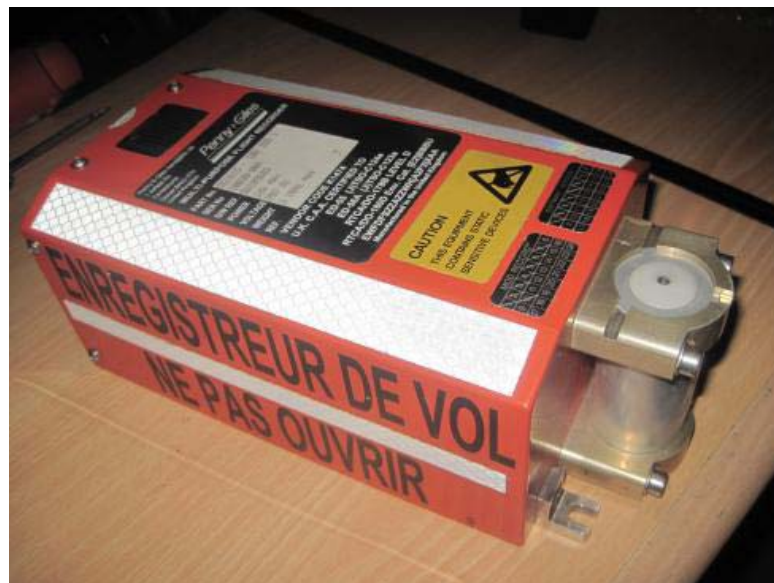
Figure 1. The MPFR

The MPFR was downloaded on 7 April 2015 at the ATSB facility in Canberra,

Australia. The recorder contained about 70 parameters of 80 hours in good quality data comprising the accident flight and previous flights, included 30 minutes of audio on four channels (P/A, Co-pilot, Pilot, Cockpit Area Microphone/CAM) and 120 minutes of audio on two channels (Combined Crew Audio & CAM).
